## RATHDOWNEY BRIDGE - AUSTRALIA

Report: Inspection of the Paint Coating - Standard Gauge Bridges Contract of 2003

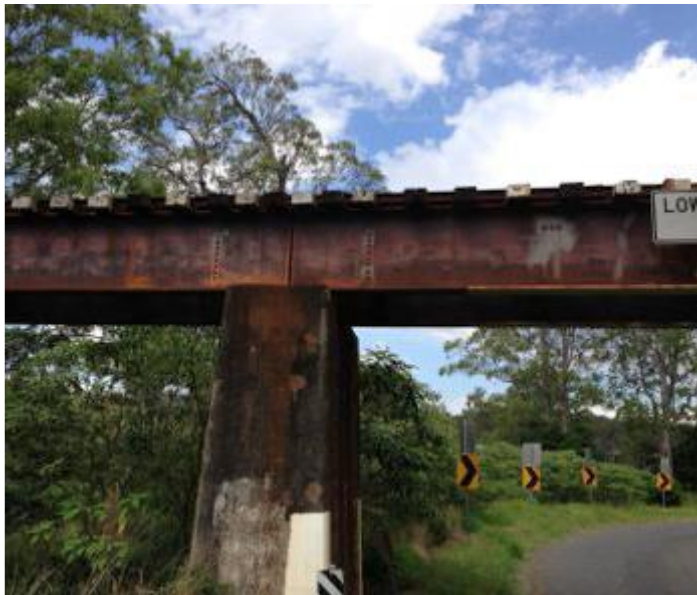
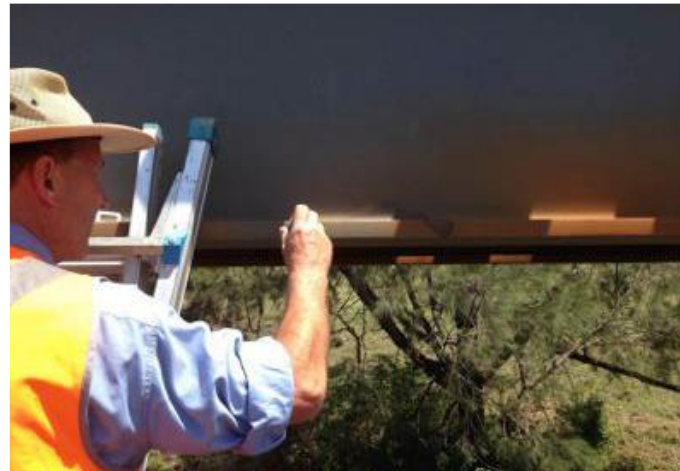
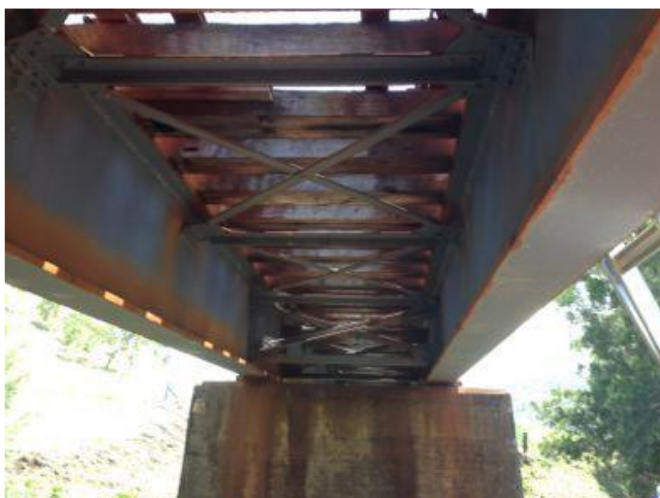
System:  
Min. ZINGA 2 x 60  $\mu\text{m}$  DFT

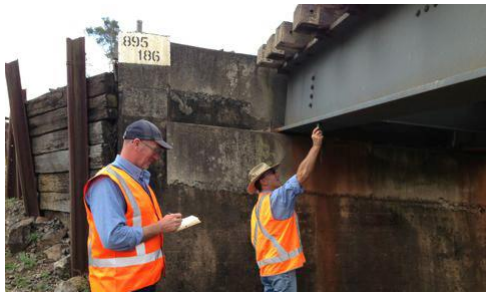
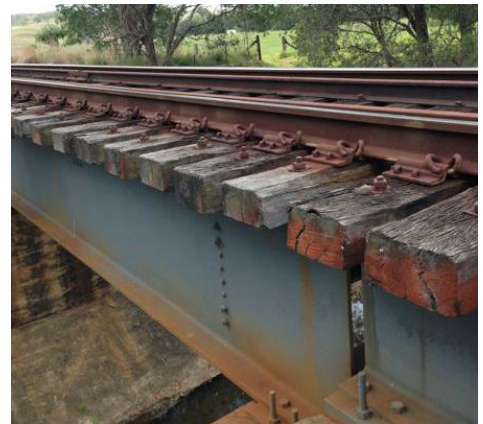
Sample Report on 1 Bridge at km 892.849 – 3 spans

- Coating condition – sound. No touch-up work required.
- No sign of rusting on bolts, nuts, threads or around rivets.
- The DFT of **ZINGA** on the underside of bottom flange is typically 150  $\mu\text{m}$ , indicating no weathering has occurred in these areas and that the original **ZINGA** was in excess of the specified minimum of 120  $\mu\text{m}$ .

- The min. DFT of the **ZINGA** on the lower part of the web (outside face) is typically 180  $\mu\text{m}$ , indicating either no weathering has occurred on this vertical surface or that the original coating was in excess of the specified minimum of 120  $\mu\text{m}$ .

- The min. DFT of the **ZINGA** on the upper surface of the bottom flange (outside) is typically 160  $\mu\text{m}$ , indicating that approx. 20  $\mu\text{m}$  of **ZINGA** has weathered away over 10 years, i.e. 2  $\mu\text{m}$  per year, assuming that the original DFT was approx. 180  $\mu\text{m}$  as on the adjacent area of the web. This area is the fastest weathering on the girders. If this rate of weathering were to continue, it is expected that partial cover of **ZINGA** will be required 25 years after the initial contract (full clean and paint).

Given that no maintenance painting has been performed on the bridges since the cleaning and coating with **ZINGA** 10 years ago, it is an extraordinarily good result that no touch-up work is required on any parts of the bridges at this time. The **ZINGA** is 100% sound, including the potential problem areas of edges, old pitting, defined edge of the coating adjacent to rust, sharp laminations and bolt threads.

- Based on an assumed weathering rate of 2  $\mu\text{m}$  per year, it is expected that only partial cover coating would be required when the coating weathers down to 70  $\mu\text{m}$  at 25 years after the initial contract (full clean and paint), i.e. in 15 years' time. Because of the guesswork in this assumption, it is recommended that good maintenance practice would require checks of coating thickness on the most exposed sections of the spans in 5 years and then every 2 years.
- It is suggested that **ZINGA** repeat the inspection of the same bridges in 5 years.
