TEATRO MUNICIPAL – RIO DE JANEIRO – BRAZIL

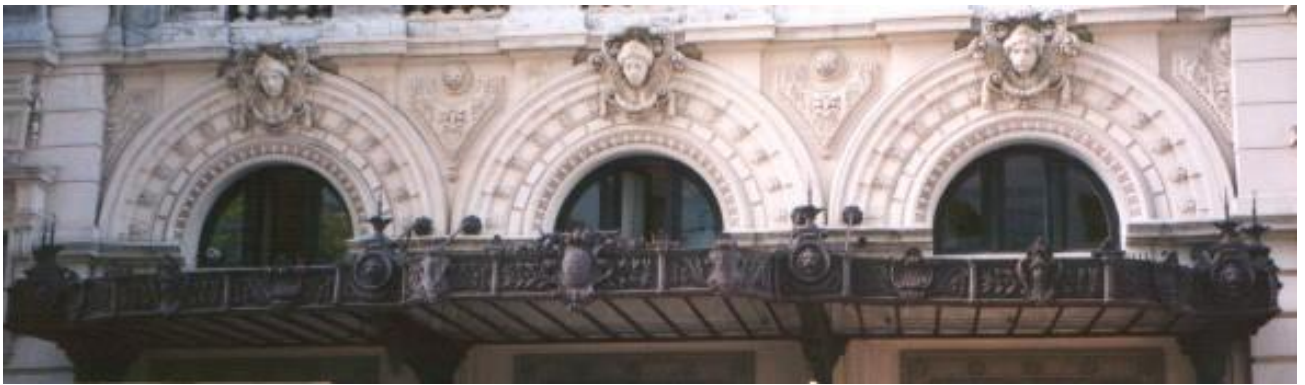
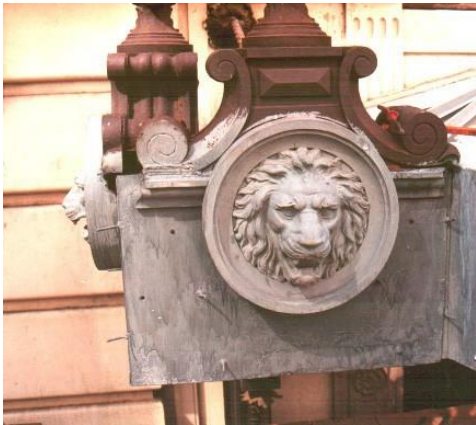
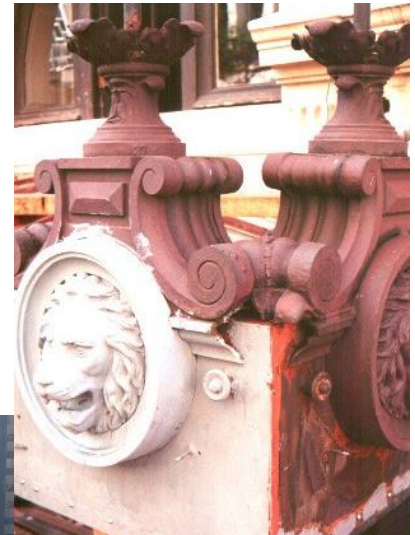
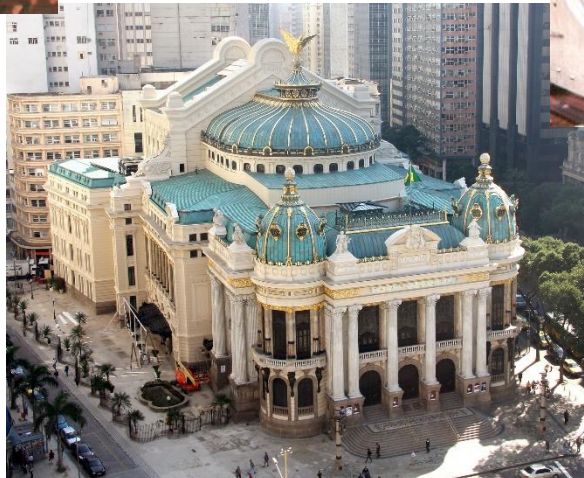
Details of the **Teatro Municipal of 1909** in Rio de Janeiro. The iron roof and the ornaments above the entrance have been protected with **ZINGA**. The theatre is a copy of the Opéra Garnier in Paris. The lean-off roof above the box-office was heavily corroded and therefore very unsafe for the public. An inspection pointed out that the iron frame of the roof and the ornaments (the lion heads) consisted of a mixture of materials: galvanized steel, cast iron and soft iron. Here and there zinc rich paints had been applied. Everything that could possibly be removed, was brought to a workshop for welding, grit-blasting and Zinganizing. The rest was prepared and protected with **ZINGA** on site, on days of low relative humidity (< 80%). Once the whole structure was reinstalled, a chocolate brown silicone topcoat was applied on top of **ZINGA**. That was done in August 2008.

ZINGA 1 x 60 µm DFT
Brown silicone topcoat

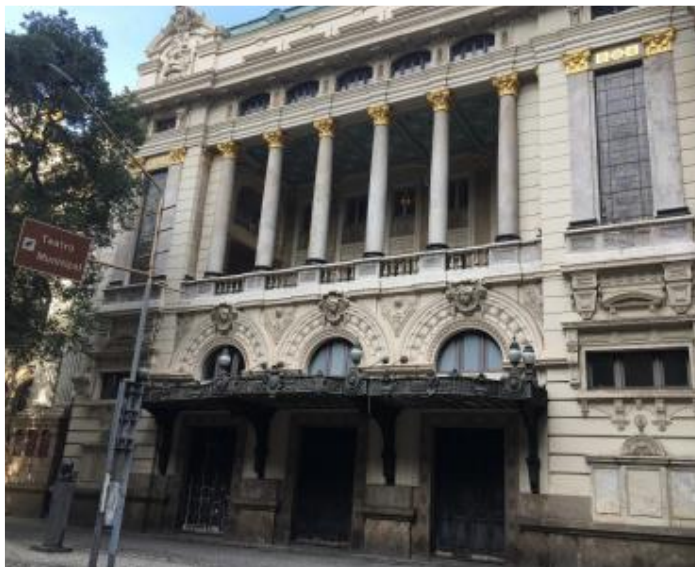
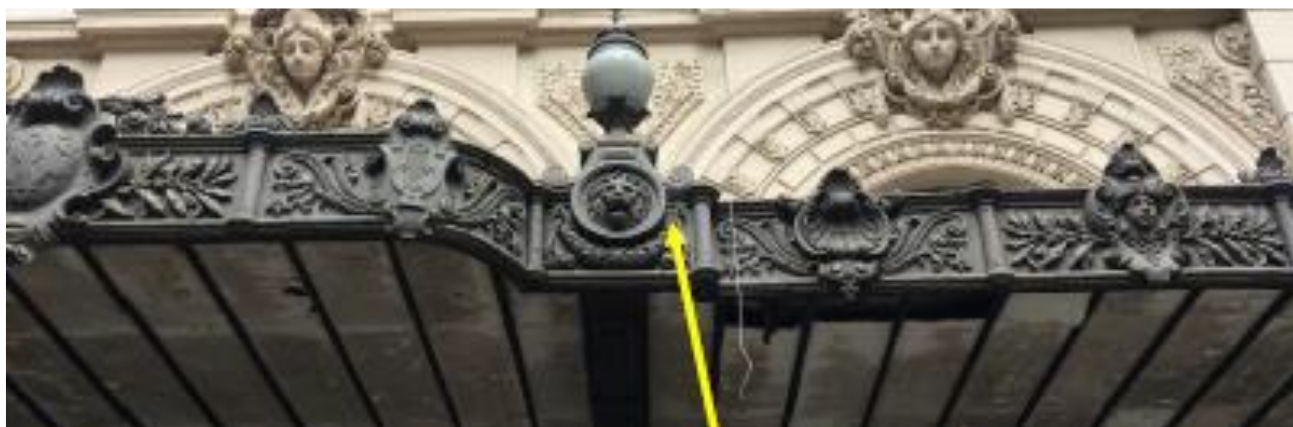
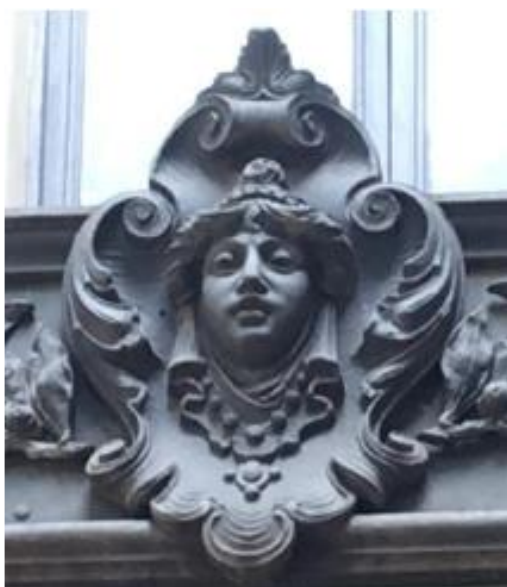
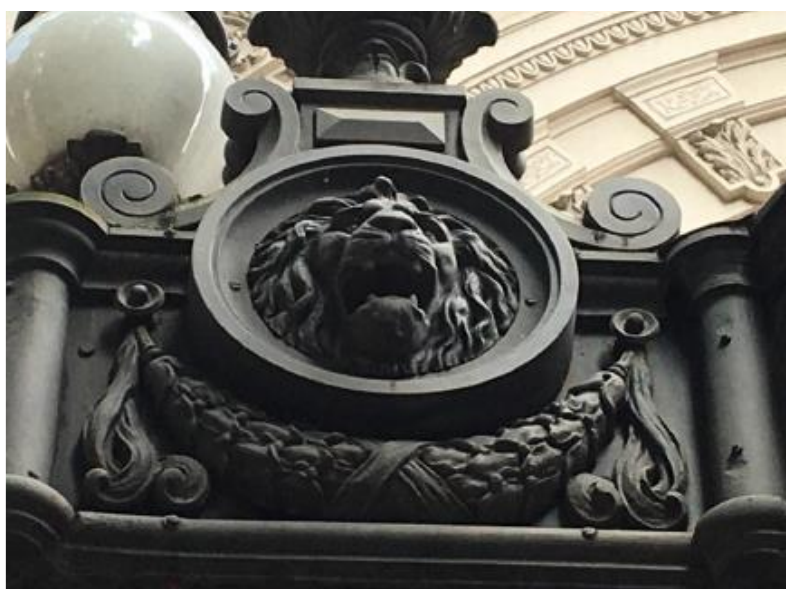
12 years later, exactly on 11th June, 2020, **ZINGA BRAZIL** made a condition survey. The brown silicone topcoat was still present, with only very few dripping corrosion from small spots.
