SILOS – EWOS CHILE – CHILE

In June 2009, the company **EWOS CHILE Ltda.** decided to repair 4 of their galvanized silos ('Planta Coronel') that were affected by gases from combustion.

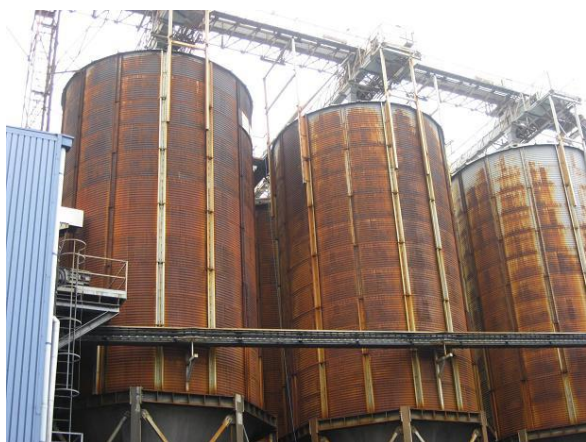
Before **ZINGA** application

The customer decided to apply two layers of 60 µm **ZINGA** on the most critical areas (contact with gases) and one layer of 60 µm **ZINGA** on the back side in order to recharge the original galvanization and keep the cathodic protection.

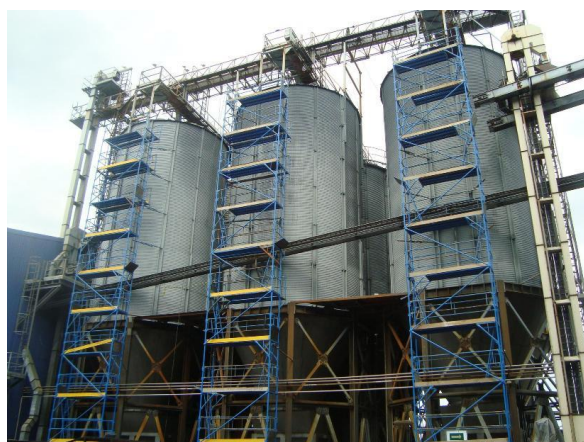
During **ZINGA** application

High pressure washing & sandblasting: SA 2,5 & Rz 75 µm

Most critical areas: ZINGA 2 x 60 µm DFD

Other areas: ZINGA 1 x 60 µm DFD

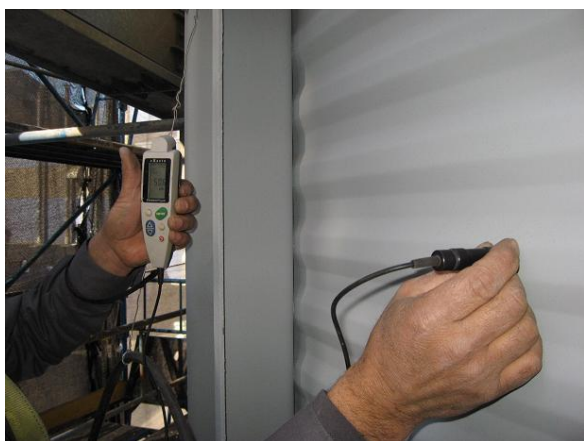
Inspection

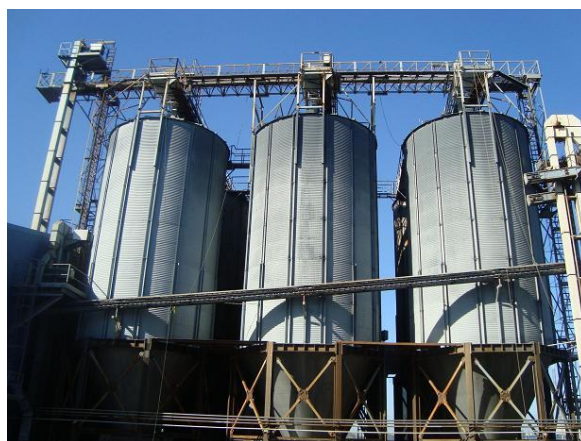
After **ZINGA** application
