BUOYS – DIRECTION DÉPARTEMENTALE DE L'ÉQUIPEMENT NOIRMOUTIER, VENDÉE – FRANCE

Subject: Test application Zinga on marine buoy in Noirmoutier.

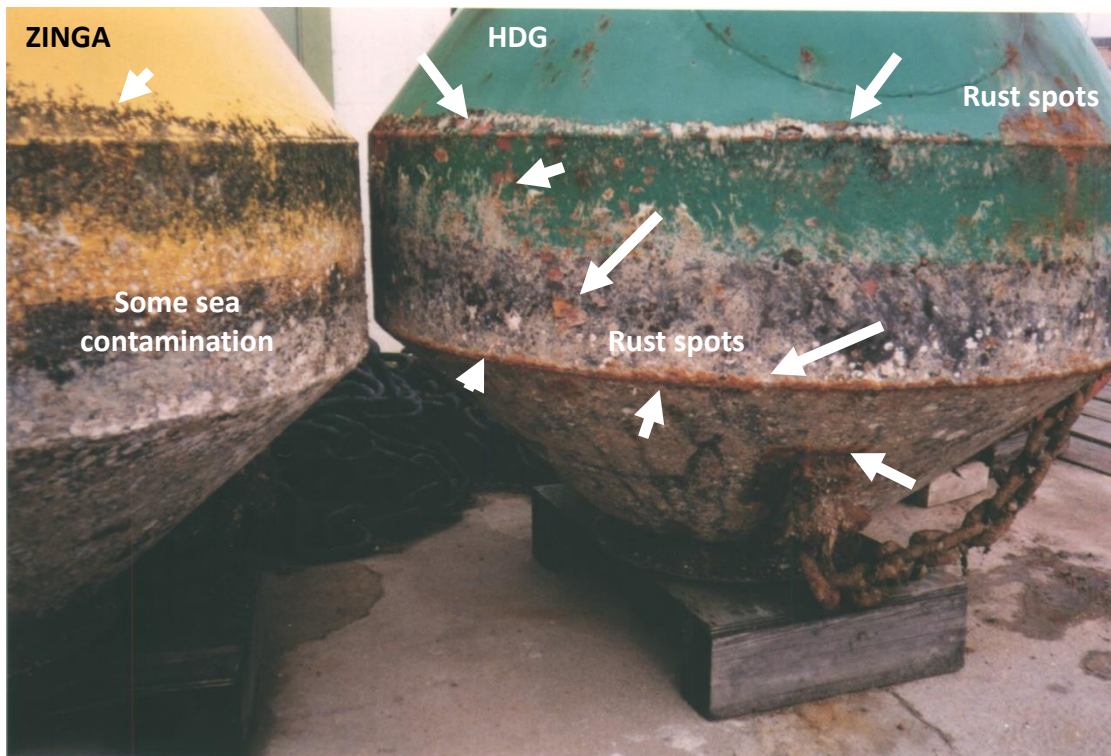
These two sea buoys have been floating in the Atlantic Ocean, in Noirmoutier, for 4 years. The yellow buoy, a mild steel buoy protected with **ZINGA**, was compared to the green buoy that was galvanized by the traditional hot-dip process. The two buoys had received the same type of topcoats with the same layer thickness, with a supplementary adhesion coating for the hot-dipped buoy.

Conclusion of this test by the **DDE**: the buoy protected with **ZINGA** showed no trace of rust, but the hot-dip galvanised buoy was severely corroded in several places.
