DÜSSELDORF AIRPORT – GERMANY

ZINGA was applied on steel structures of the Airport of Düsseldorf in 1990, namely on a hangar, with a height of more than 30 m, that serves as testing area for the engines of large commercial airplanes and of which the interior side has been insulated with panels. There is a steel structure between the insulation panels and the concrete building. The entire steel structure has been protected with **ZINGA** as unique system. The applied **ZINGA** layer thickness was 120 µm. The company **DILLINGER STAHLBAU** executed the job.

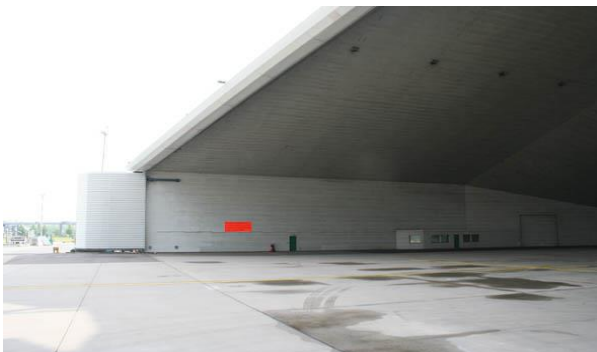
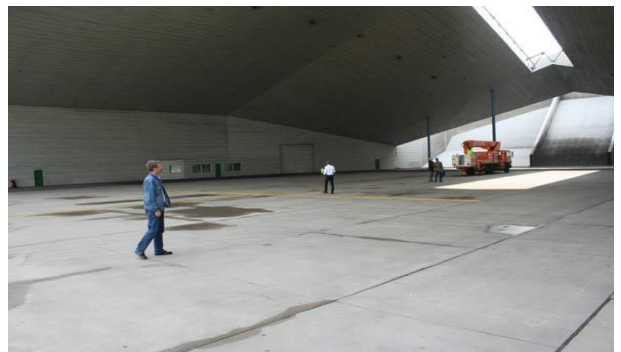
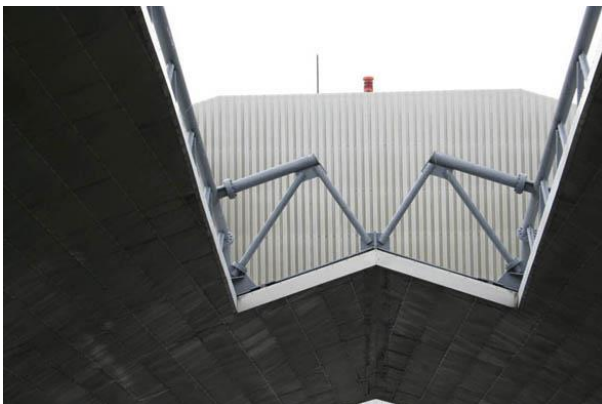
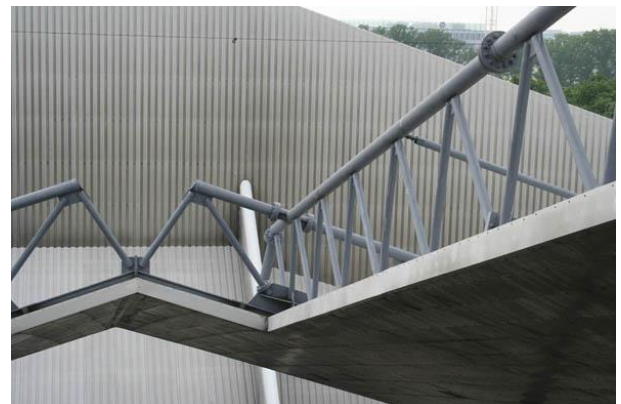
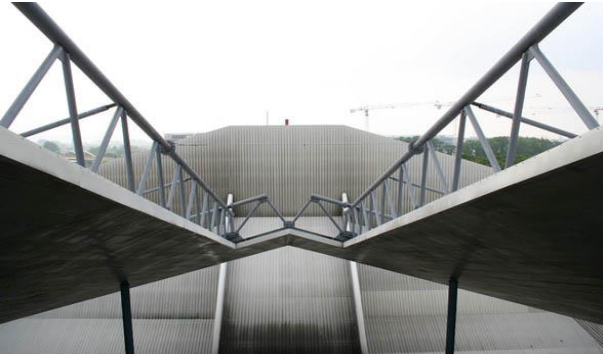
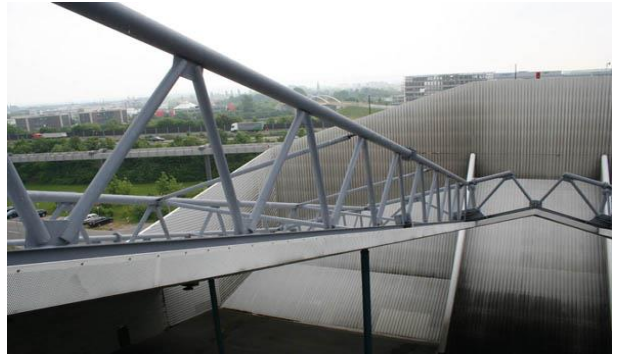
Some time before checking the structure's condition in presence of the airport authority in **May 2008**: the steel structures on the outside of the building and on the roof have been over coated after the 10-years guarantee-period, despite the fact that there were no complaints or traces of corrosion. This was done for aesthetic reasons and given the aggressive environmental circumstances on the outside of the building. The topcoat consisted partly of a blue colour paint and partly of a MIO based paint.
