KALVØYA BRIDGE – BÆRUM – NORWAY

In 1985 **ZINGA** was applied by brush on the steel structures of the **Kalvøya Bridge** located in the **inner Oslo fjord**. Paint gloves were used for the carrying cables.

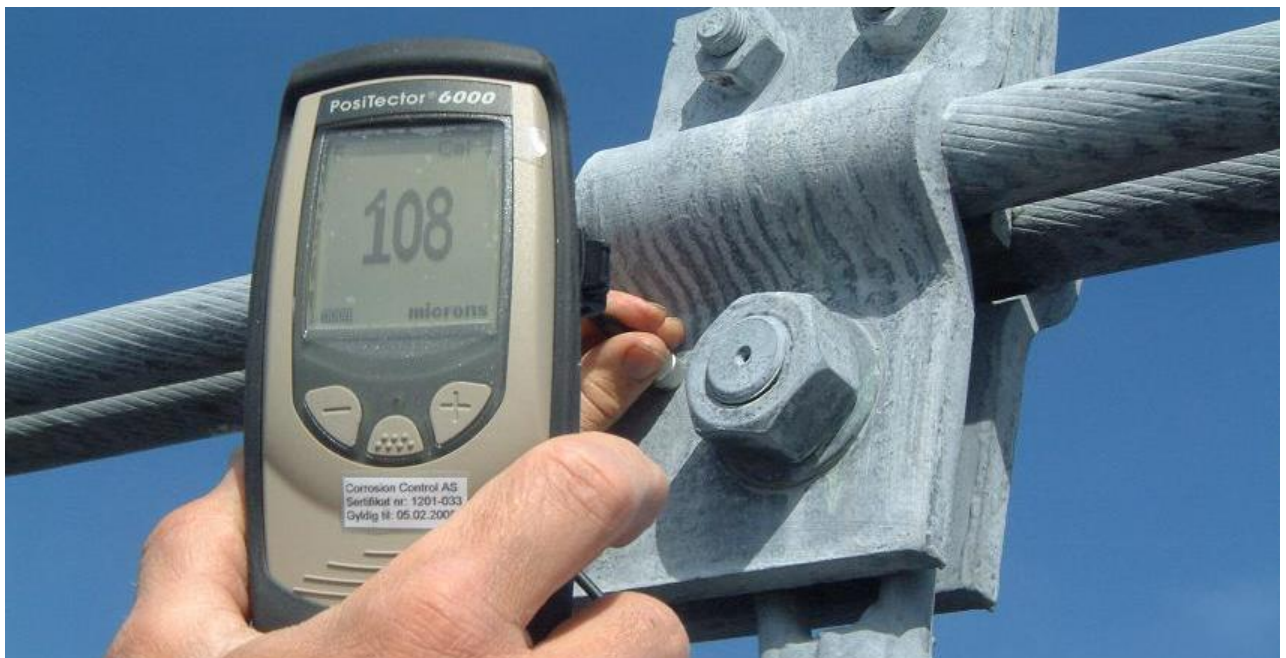
In February 2010, **25 years after the application**, the layer thickness of **ZINGA** on the Kalvøya Bridge was measured.

The loss in layer thickness after 25 years was on average only 30 µm.

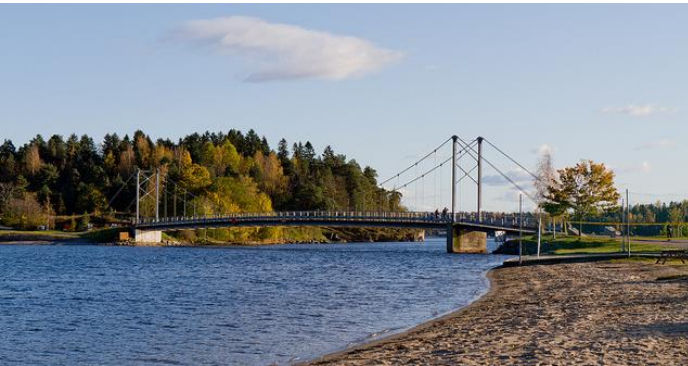
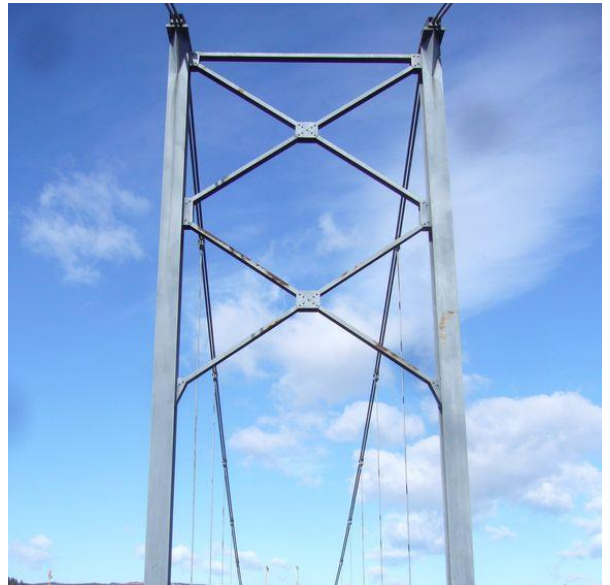
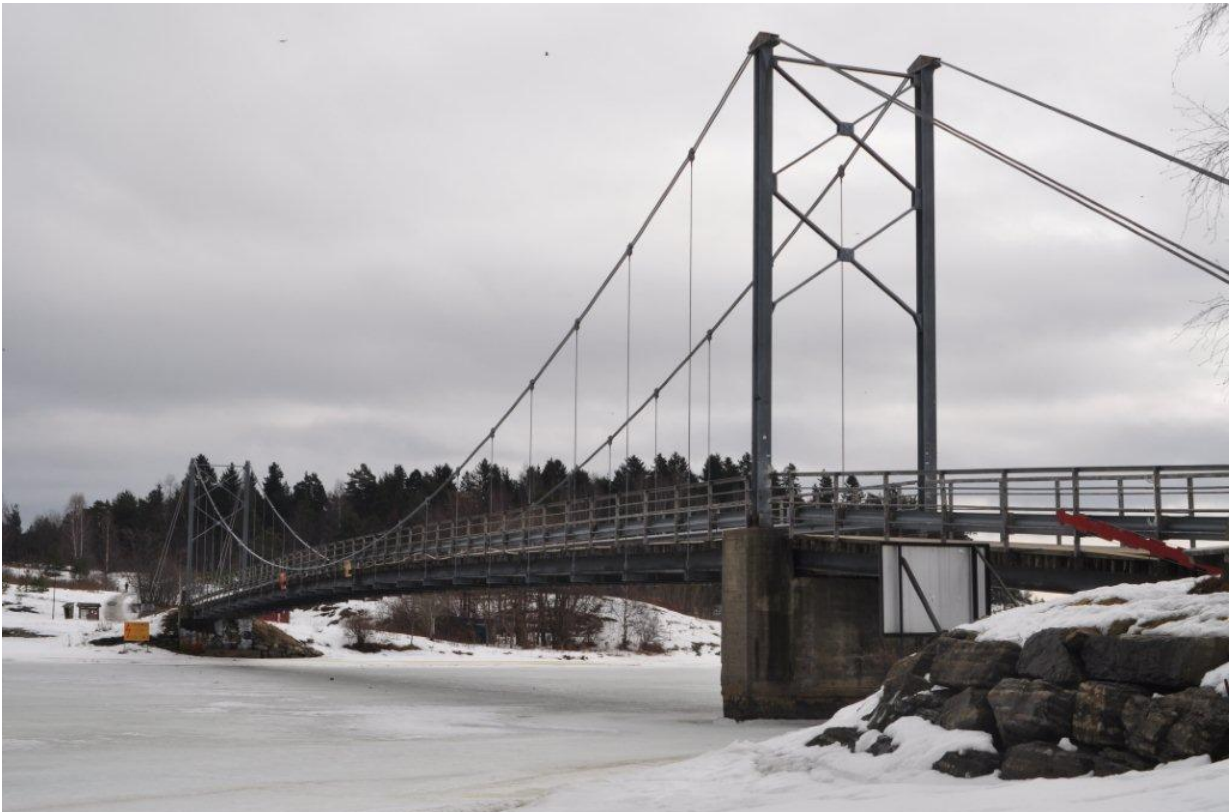
In November 2011, i.e. **26 years after application**, an inspection on the Kalvøya Bridge was done by **Sven Ola Johnsen (FROSIO inspector)**.

"Good condition with no visible rust / pits on towers, beams, cables, hangers and railings, only locally "small rust spots".
