## GUARDRAILS – LTA – SINGAPORE

In 2004 **ZINGA** was specified for the rehabilitation of guardrails at ECP Service Road and Kampong Java Road. The guardrails belong to **LAND TRANSPORT AUTHORITY (LTA)**, and they were previously Hot Dip Galvanized and installed in 1994.

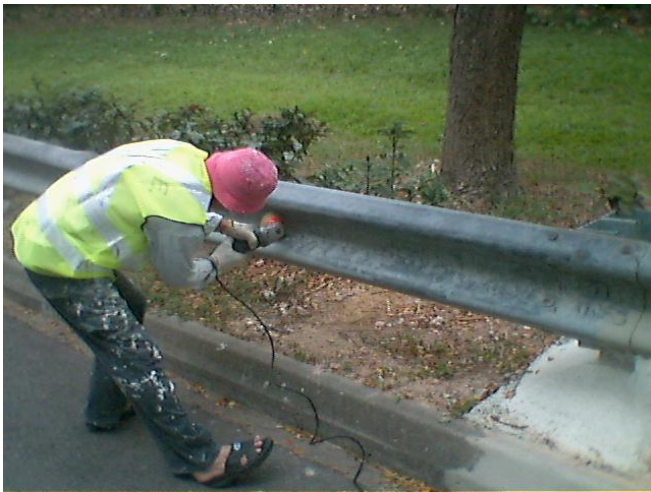
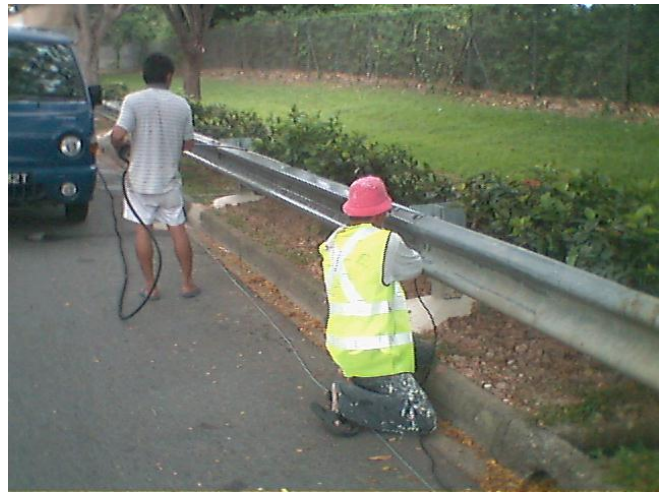
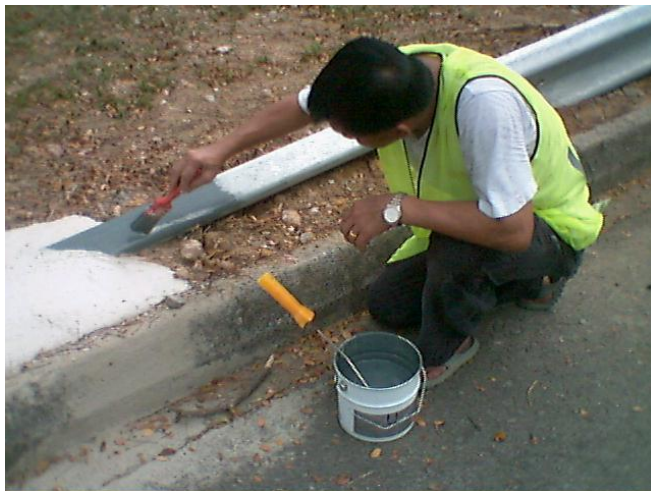
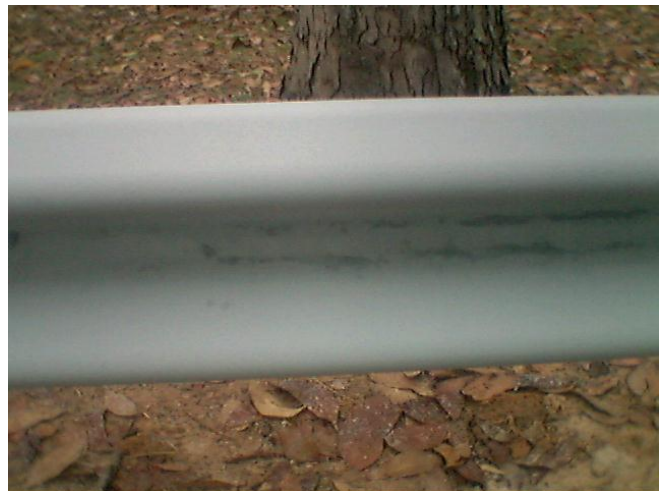
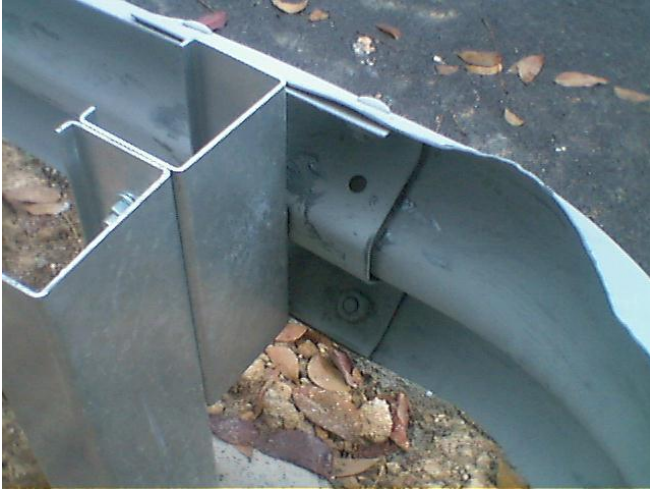
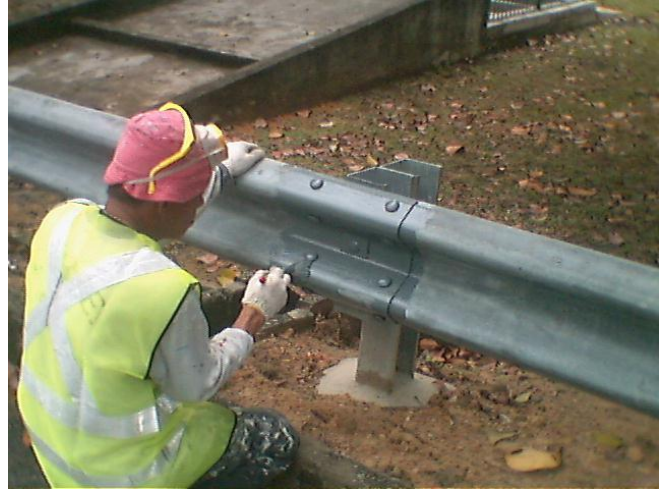
A combined length of 1 km of guardrails were Zingalized. Below you can see some pictures of the application of **ZINGA** that was carried out. To enable cathodic protection of the guardrails with a 10 year warranty against corrosion, the surface preparation team was first using mechanical power tools and wire brushes followed by water jetting to remove loose rust and contaminants. The application of **ZINGA** was first done by brush and then by roller.

System:  
ZINGA

2 x 40 µm DFT  
(brush & roller)

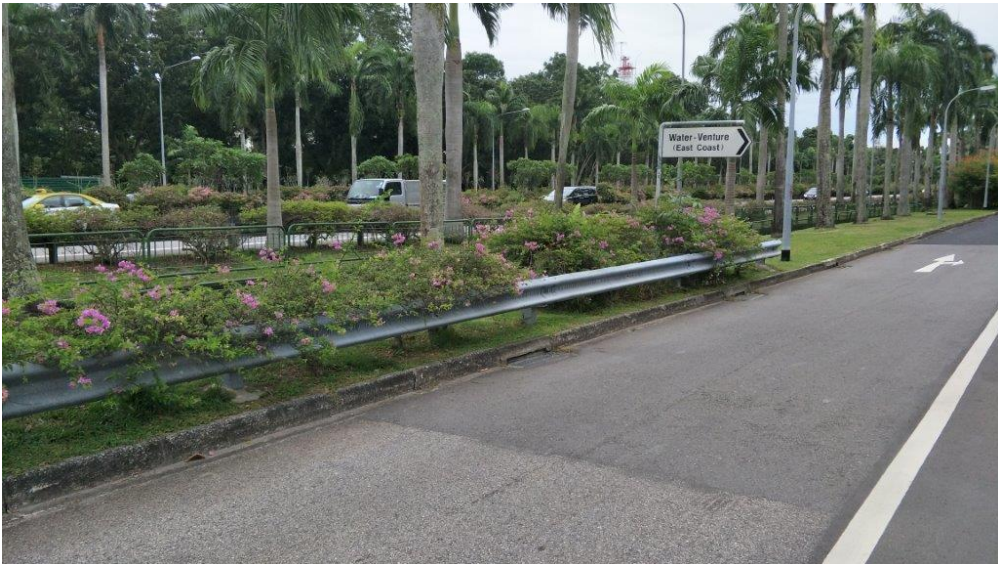
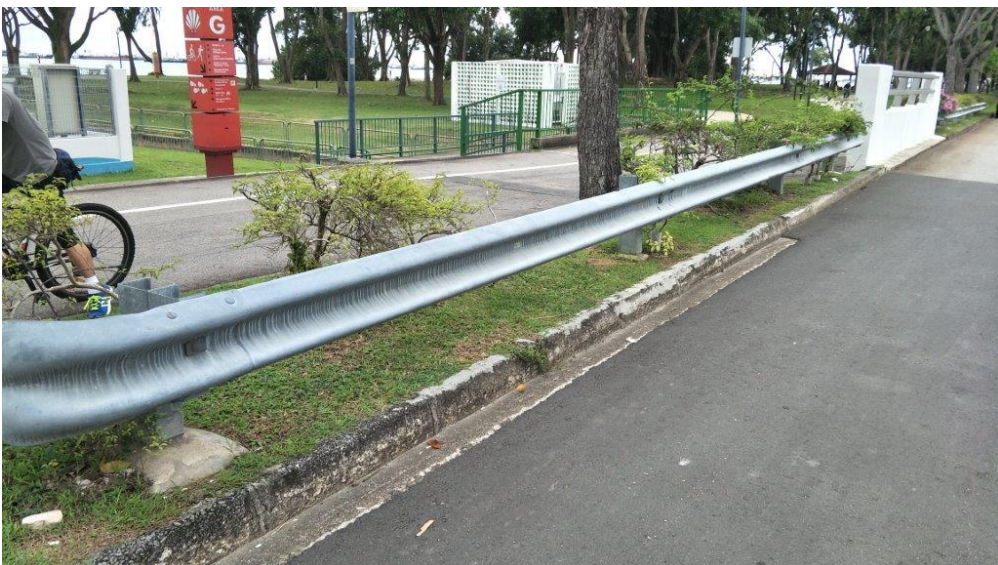
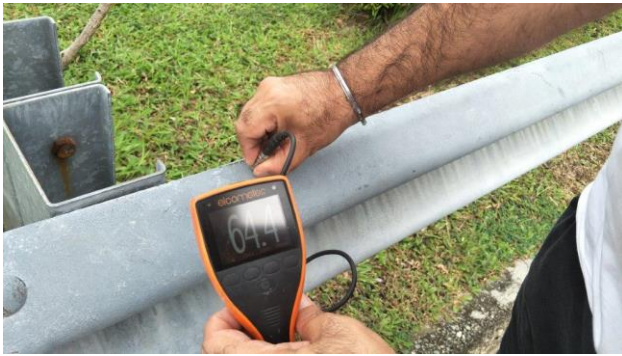
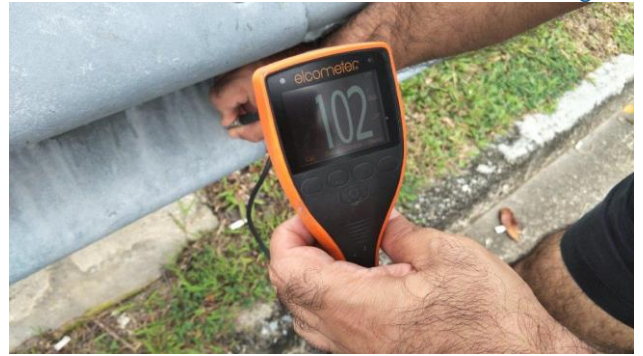
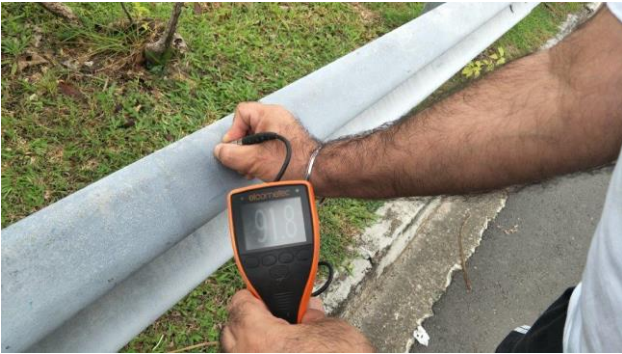
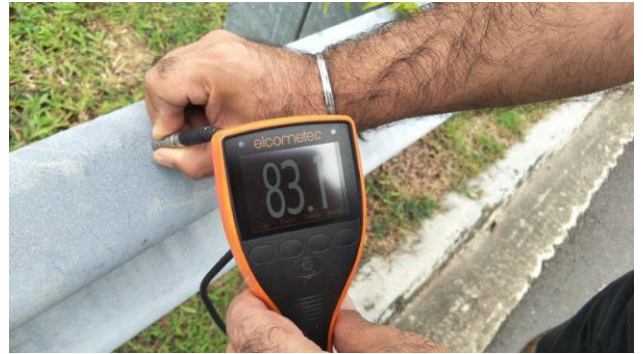
Condition survey of ECP SERVICE Road Rails in December 2017,  
**13 years after ZINGA application.**

**Conclusion: after 13 years, ZINGA is still intact and NO Corrosion was found.**

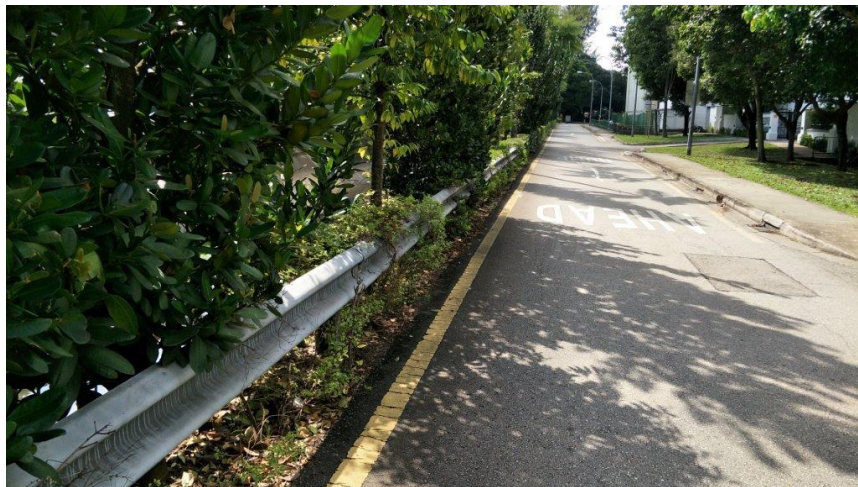
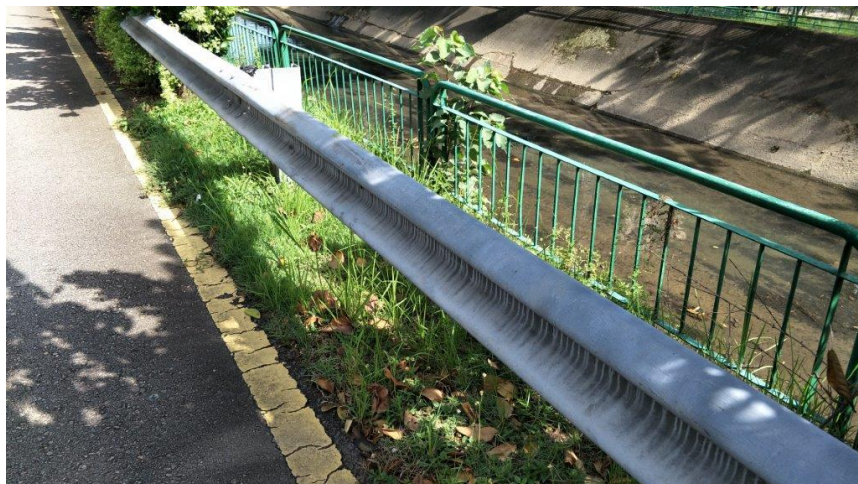
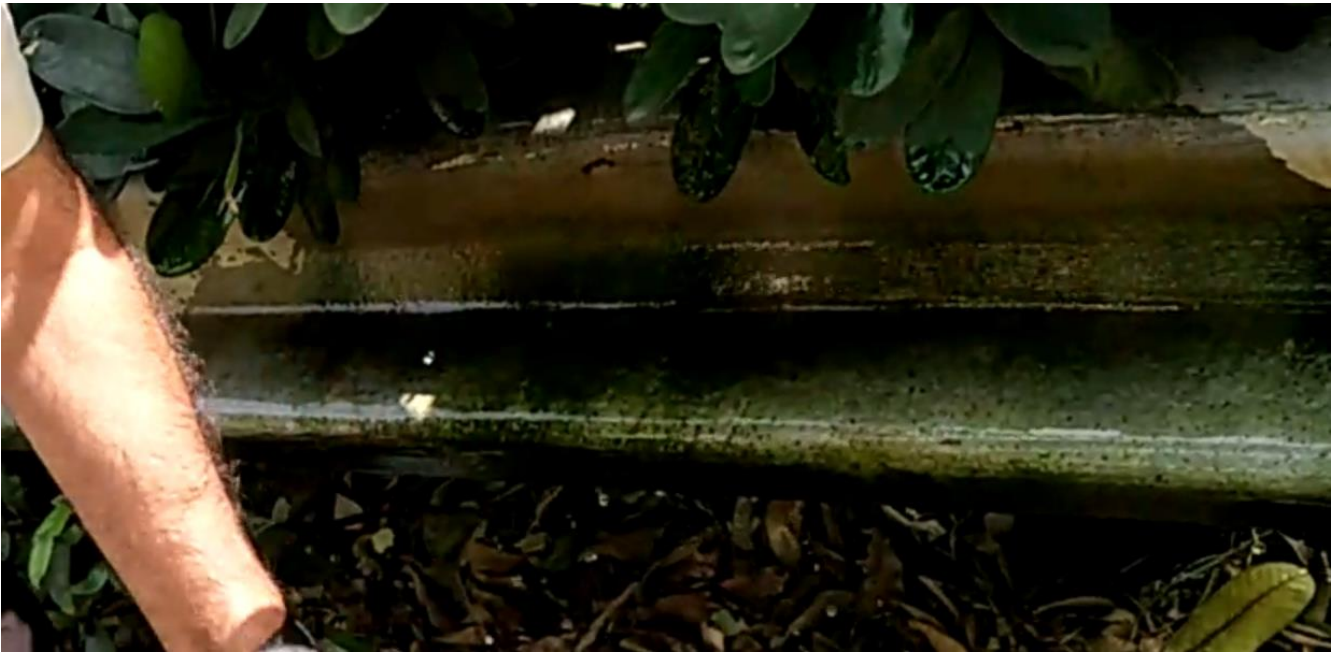
Condition survey of KAMPONG JAVA Road Rails in December 2017,  
13 years after ZINGA application.
