REF: MX-MI-NB-TC-TR-ZC – Machinery rims gold mine – EN – 20/02/2024 – ZP0445

## Machinery rims gold mine – Oaxaca, Mexico

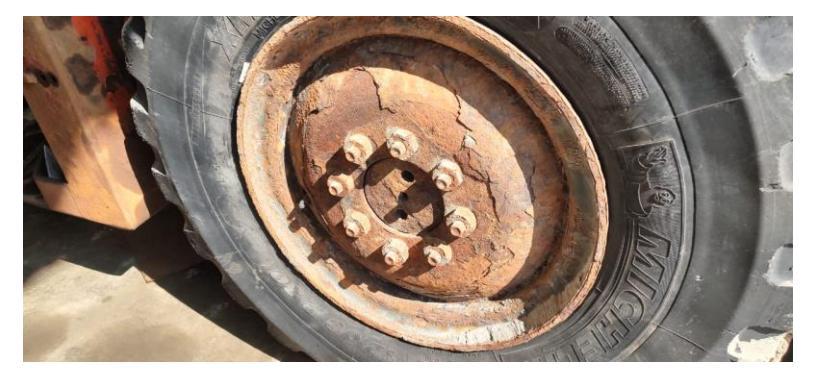
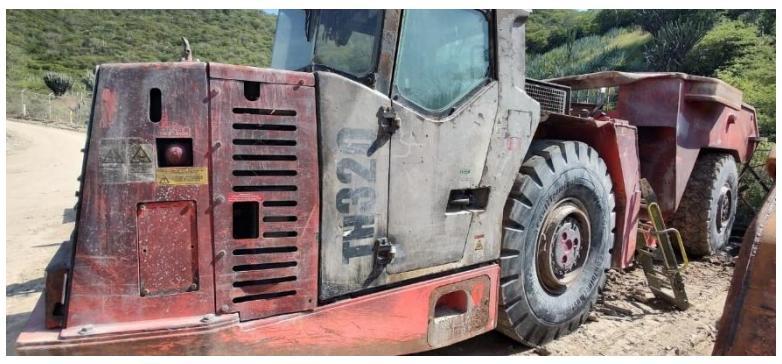
A Mexican gold mining company experienced severe problems on their mining machinery rims used in their underground mines, where high levels of moisture caused corrosion, leading to rapid deterioration. The mine reported that their machinery's wheels would typically become practically useless within just one month due to corrosion.

To address this issue, a system was proposed, which involved applying a **ZINGA** system to the rims.

System: Surface preparation: sand-blasting to SA 2.5 ZINGA 60 µm DFT ZINGACERAM HS 120 µm DFT ZINGACERAM PU 60 µm DFT (by brush & spray equipment)

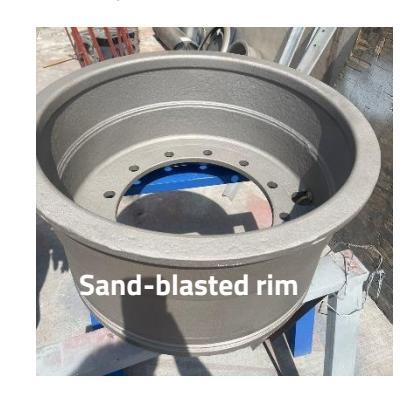
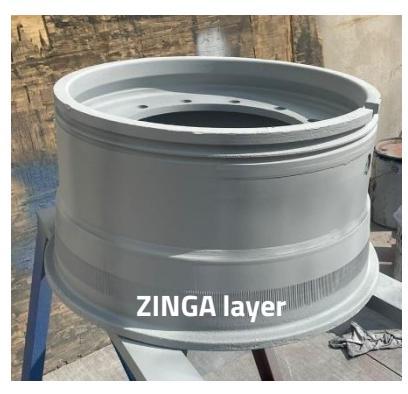
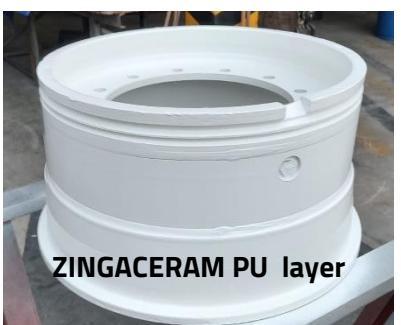
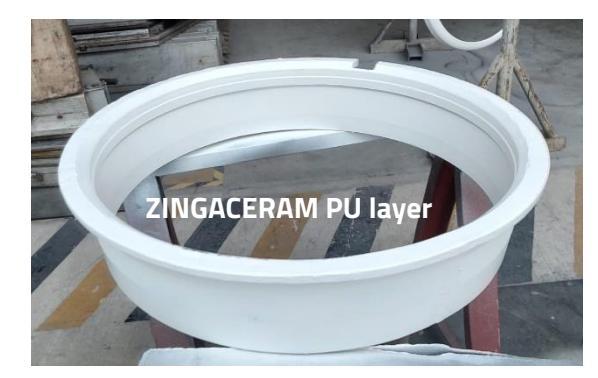
The use of the **ZINGA** system proved to be a durable and an effective solution in combating corrosion and extending the lifespan of the machinery rims.
