Update on the Storage Tanks in Bangladesh – ZM internal circulation

Zinga duplex systems

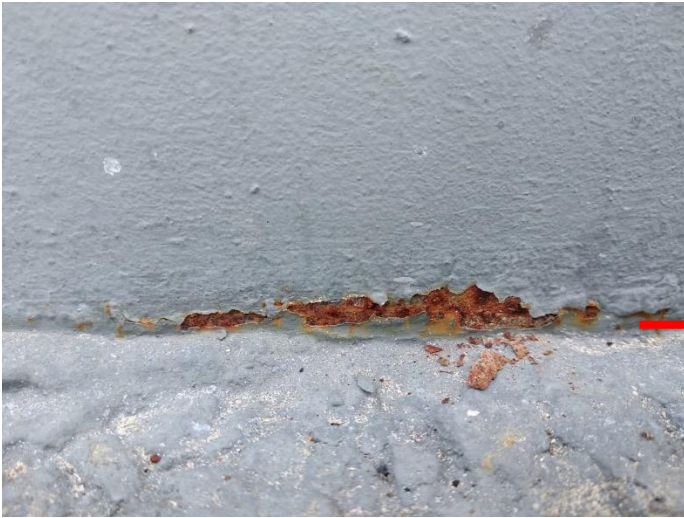
First tank blast-cleaned exhibited corrosion on the bottom 300 mm of the tank-wall above the concrete plinth. Why? The tank was not correctly washed down, leaving abrasive on the steel.

When slurry or vapour-blasting any structure, the water-blasting on the rinse-cycle must never be done at 90° to the structure, as it causes abrasive and other debris to gather at the lower part of the structure. Tangential water-blasting takes the debris away from the structure's base

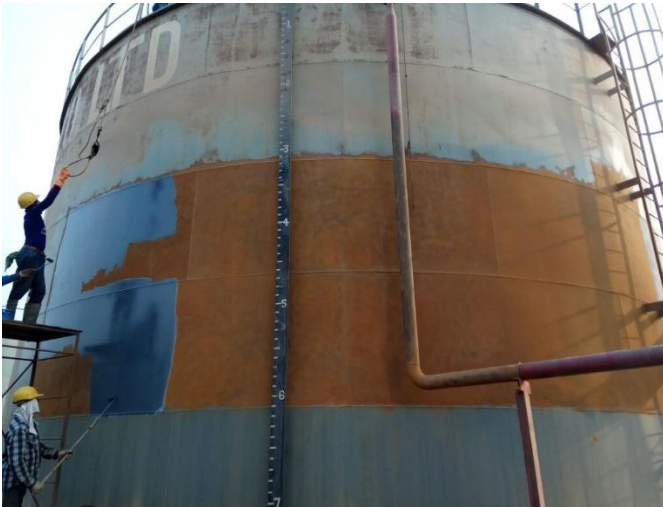
Removing the old coating system

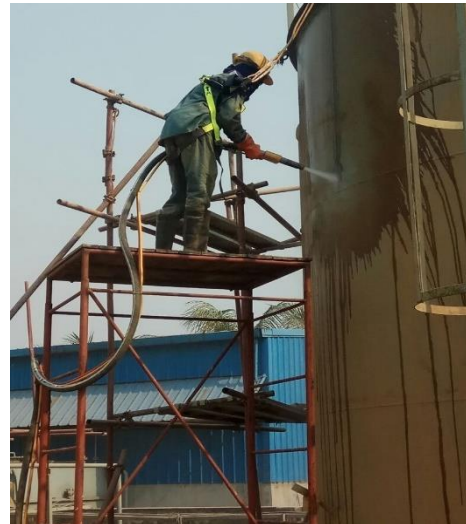
Vapour-blasting with a Satblast unit

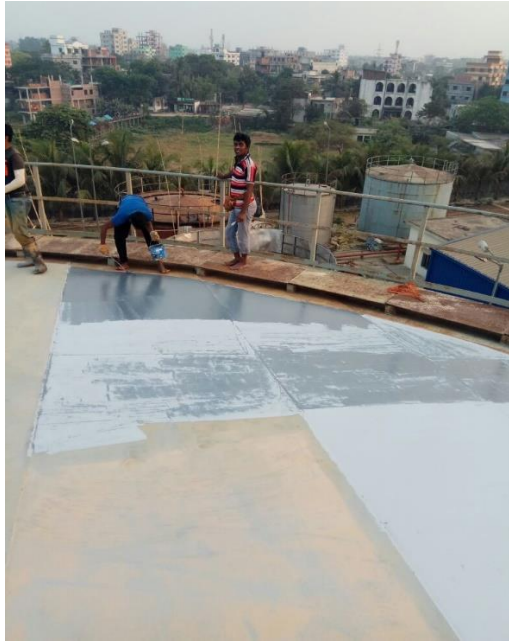
Roof painting

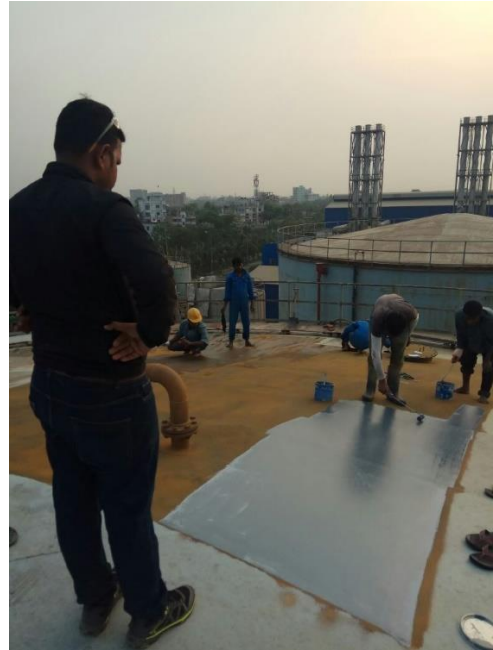
Roof painting

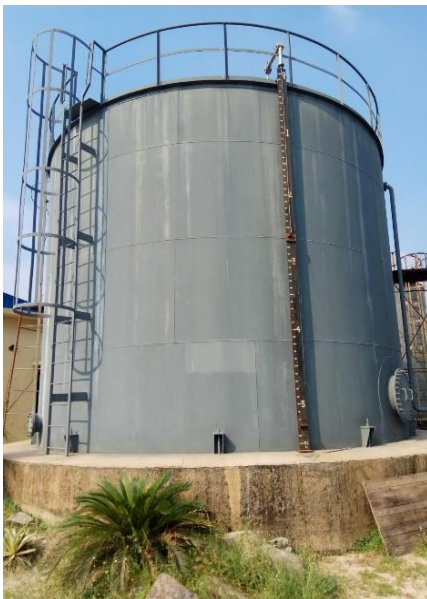
Zinga layer applied

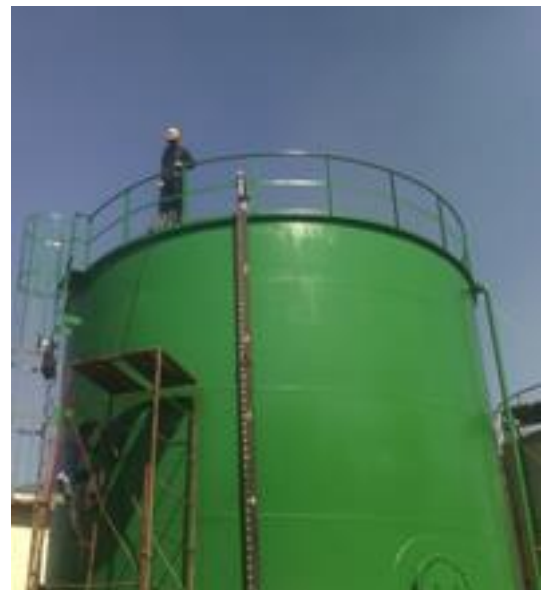
Local PU enamel applied in duplex

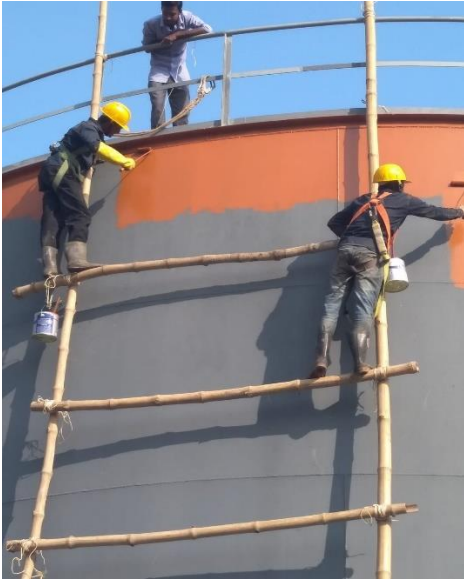
Home-made scaffolding – PU application

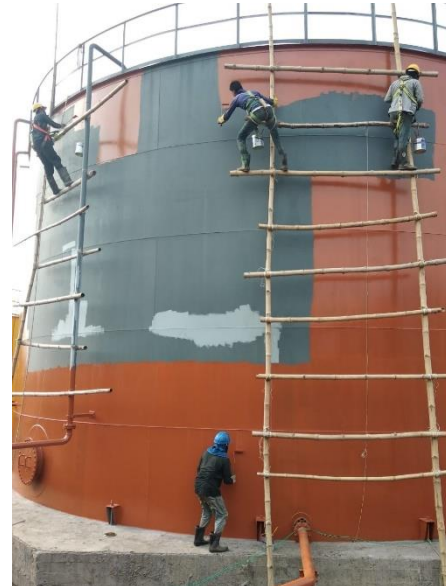
Making good progress

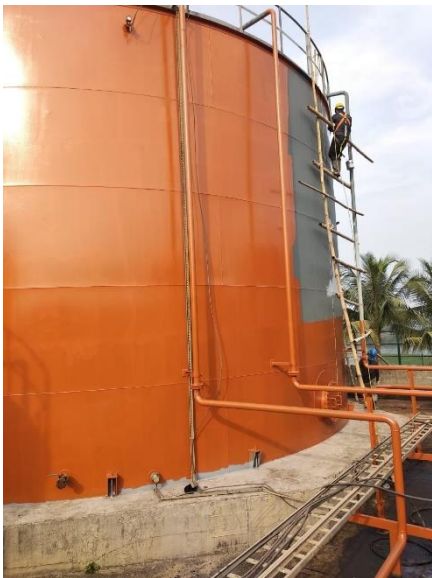
A good gloss on the PU/acrylic finish
