BOMMESTAD BRIDGE – E-18 Vestfold, NORWAY

The **Bommestad bridge** located on the E-18 in Vestfold, Larvik, Norway, was refurbished from 2000 till 2001, for **SVV – Statens Vegvesen (Norwegian Road Authorities)**.

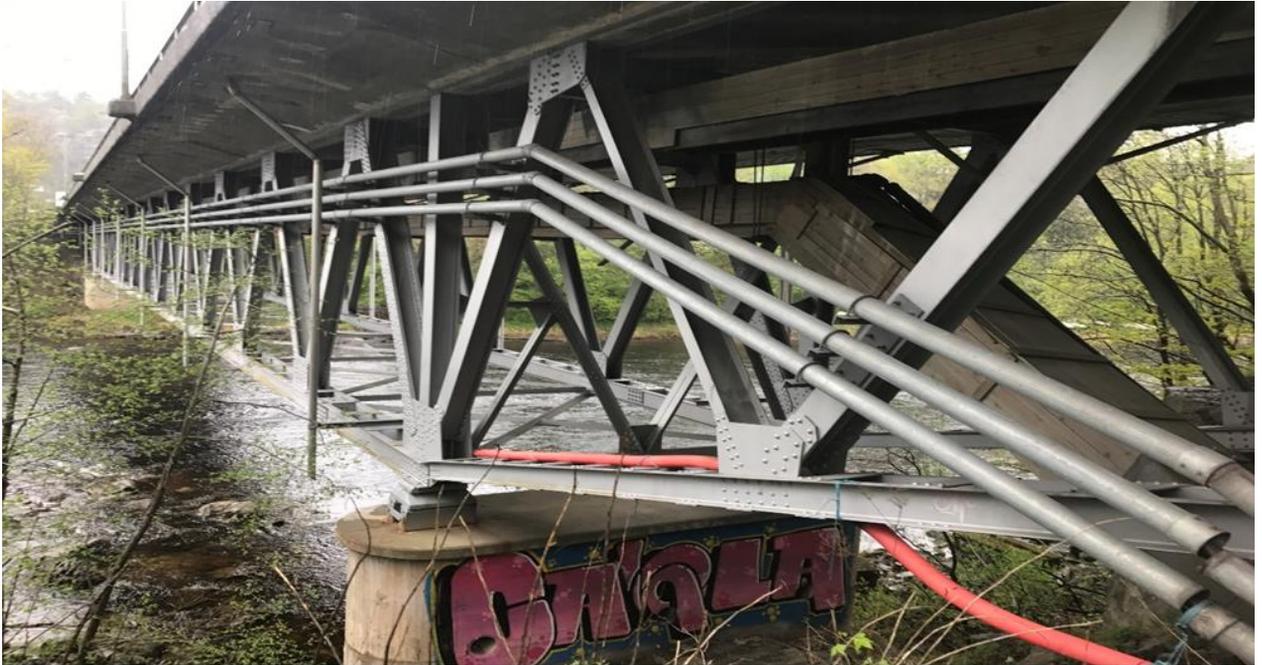
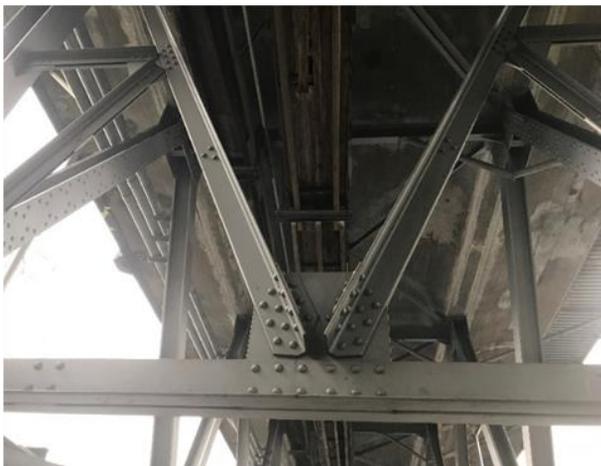
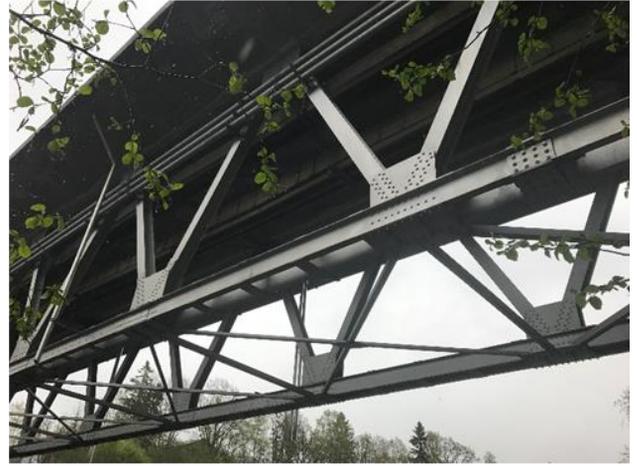
These photos are from **May 2017, after 15 years of exposure**. The system is still intact without any sign of breakdown or failures. Even in complicated areas such as around bolts, nuts and rivets there are no failures. The system is believed to protect the steel structure for many more years to come.

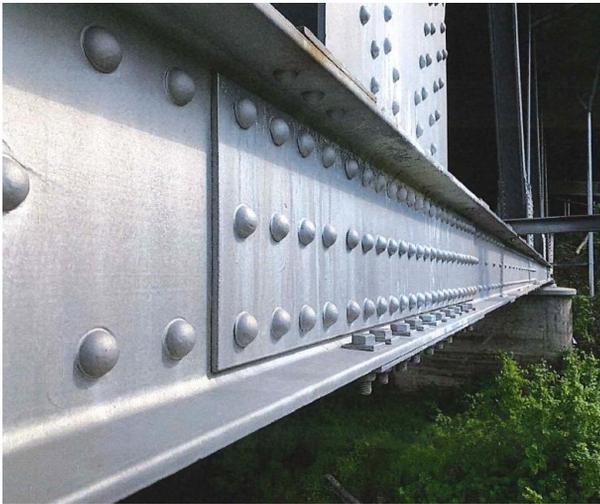
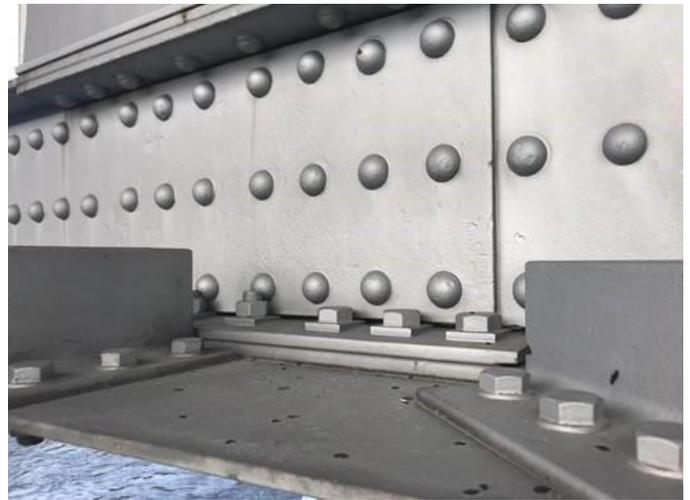
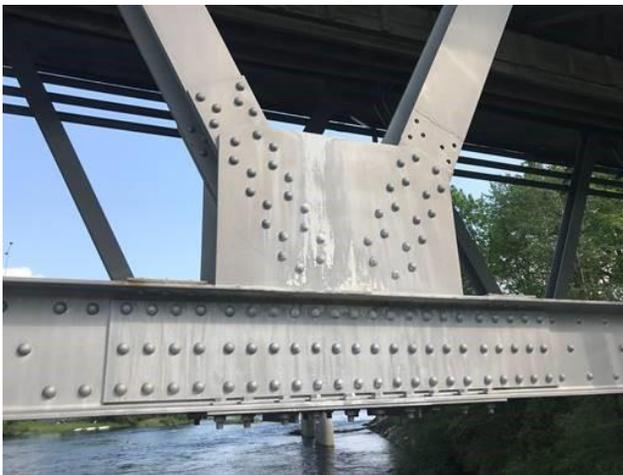
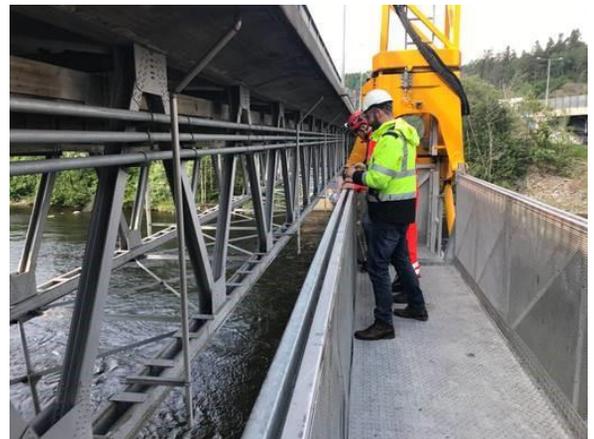
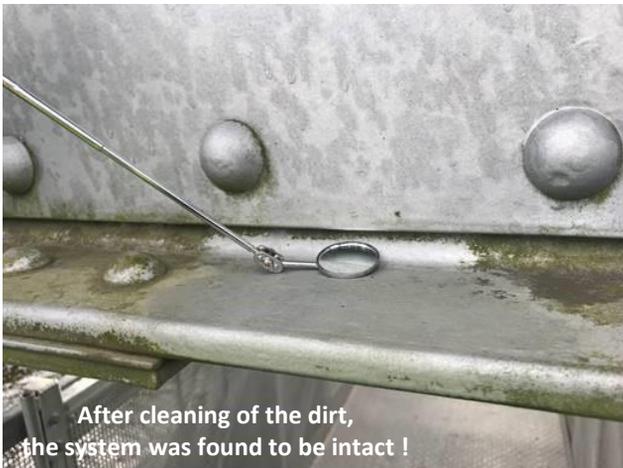
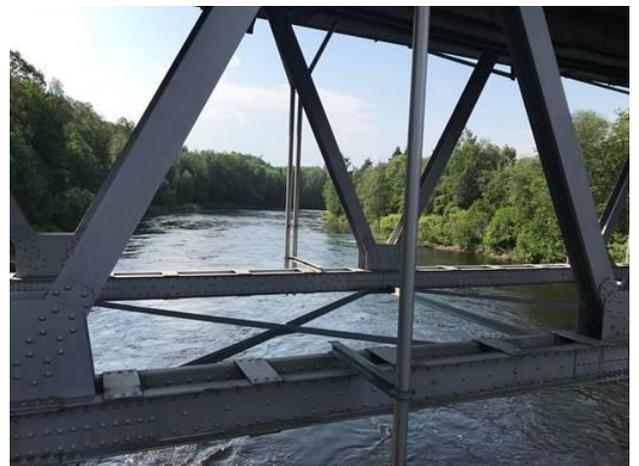
The below pictures were taken on 6 June 2019.

“In my opinion, the protection was good as it was applied in 2000/2001. As far as I know, it was estimated a life time of 20 years, which has been fulfilled.”
