## TRANSFORMER STATION of SLAVETICE – CZECH REPUBLIC

**ZINGA** was used on the pylons of the Slavetice Transformer Station, to repair the Atmofix anti-corrosion protection.

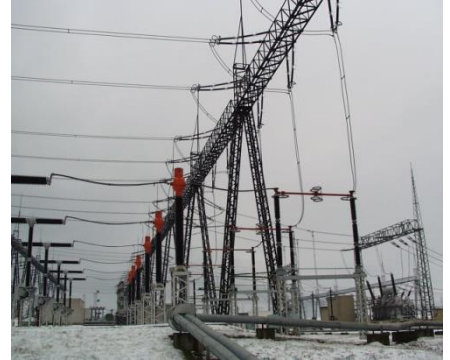
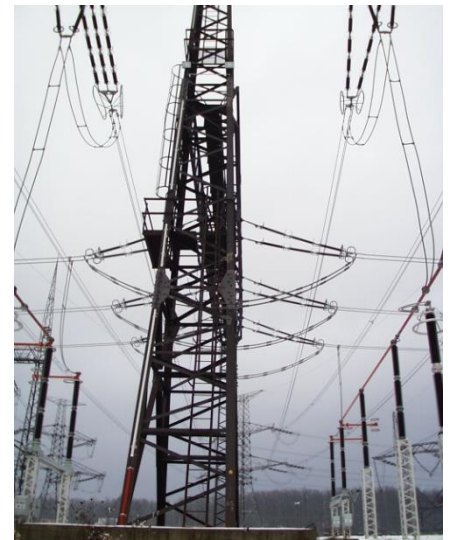
**ZINGA** was applied basically on the inner surfaces between 2 metal plates. The problem was that the corrosion between the metal plates caused such pressure that the bolts broke. In most cases they applied **ZINGA** also on the outer surface of the metal plate. All other surfaces, that look black, are still covered with the old protection layer Atmofix. The application of **ZINGA** started in 2000 and was continued until 2002. These pictures were taken during an inspection in January 2003.

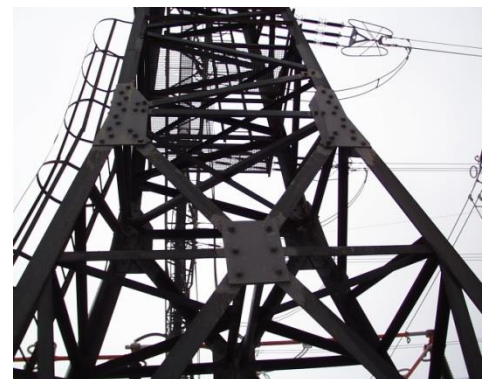
System:  
**ZINGA 2 x 40 µm DFT**
