PORT CRANES – OFFICE TOGOLAIS DES PHOSPHATES (PHOSPHATE MINE OFFSHORE) – TOGO

The phosphate mine belonging to the “**Office Togolais des Phosphates**” has 2 offshore cranes at 1.6 km in the sea. These cranes are linked to the inland stock department by means of a conveyor. These cranes are very mobile and weigh 325 tons each.

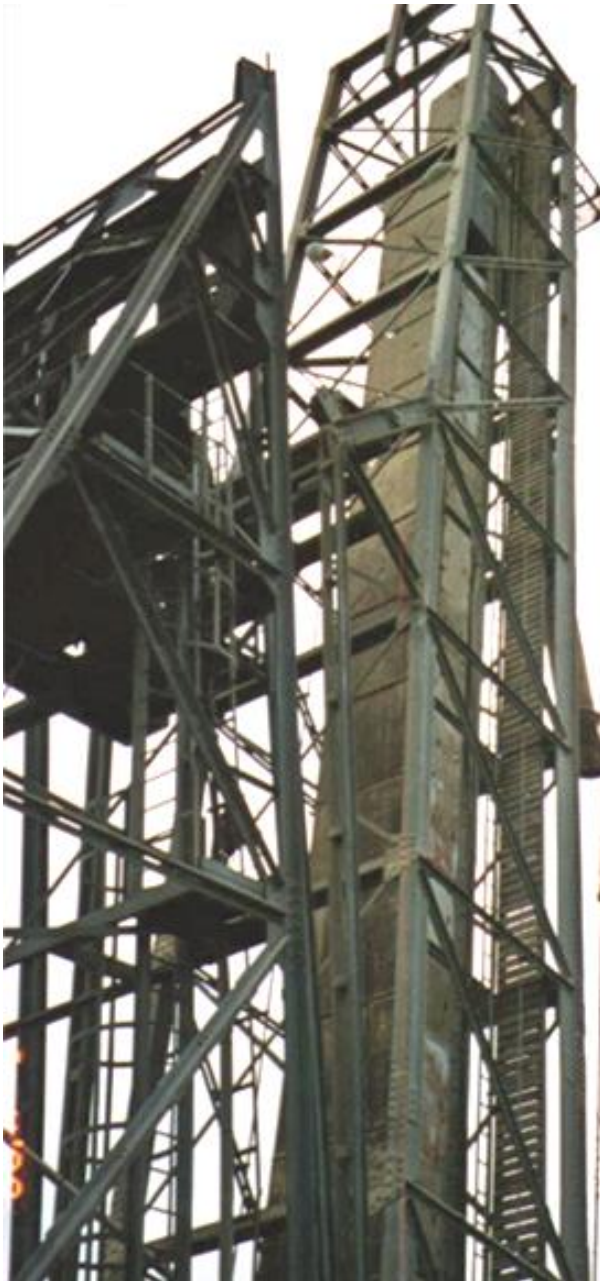
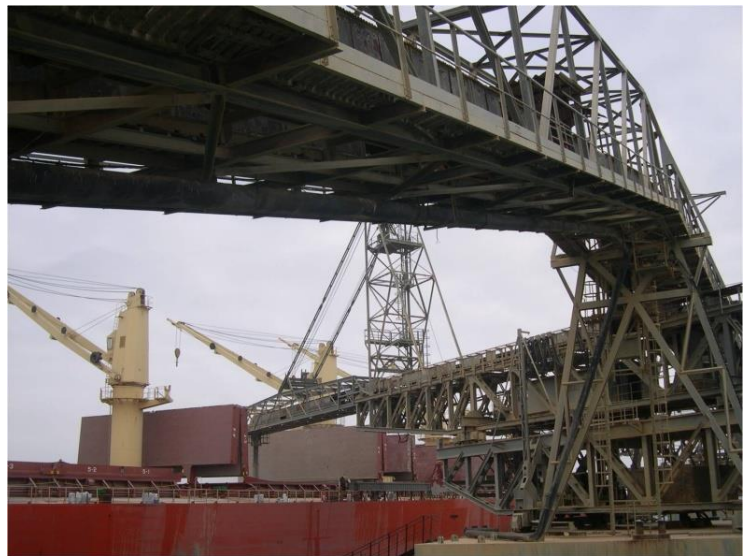
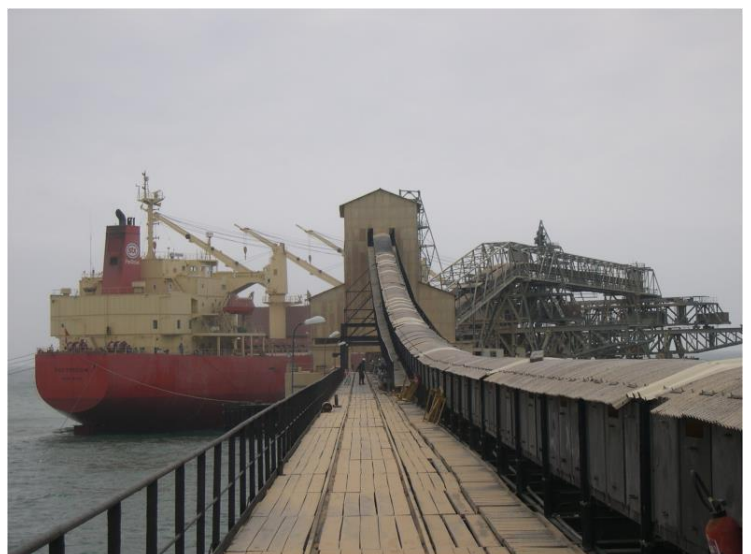
These two cranes and the conveyors were heavily corroded and it has been decided that they had to be protected by an anti-corrosion system providing cathodic protection: **ZINGA** was chosen.

In 1994 the cranes were repaired by the French company **AFRICAIN DE MONTAGE** (Group Baudin-Châteauneuf). A permanent service and maintenance was compulsory during the repair of the cranes. After grit-blasting, the structures needed to be repaired by welding.

The application was done from 1995 to 1996 under the supervision of the French controlling organism **SOCOTEC**.

System:
Surface Preparation: Grit blasting
ZINGA 2 x 60 µm DFT

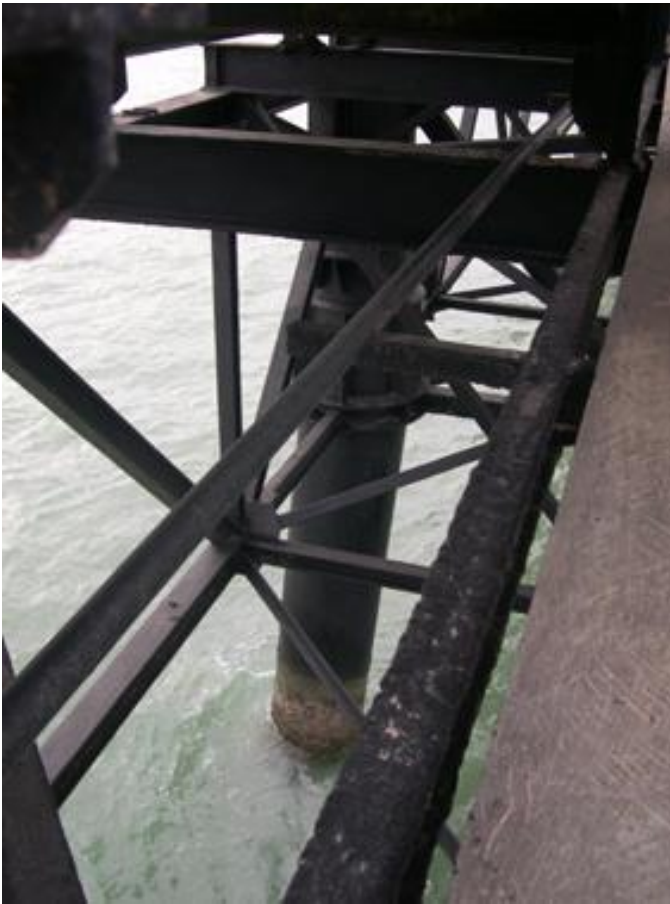
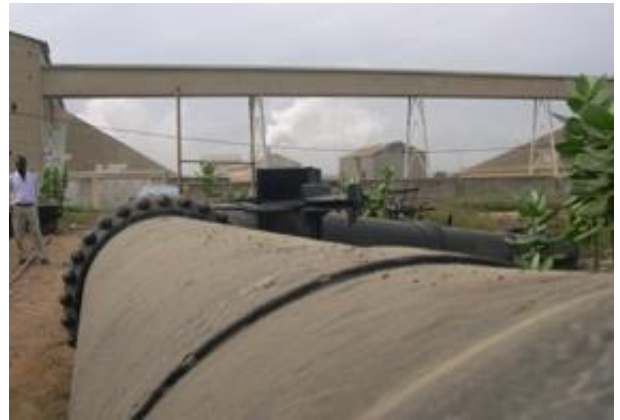
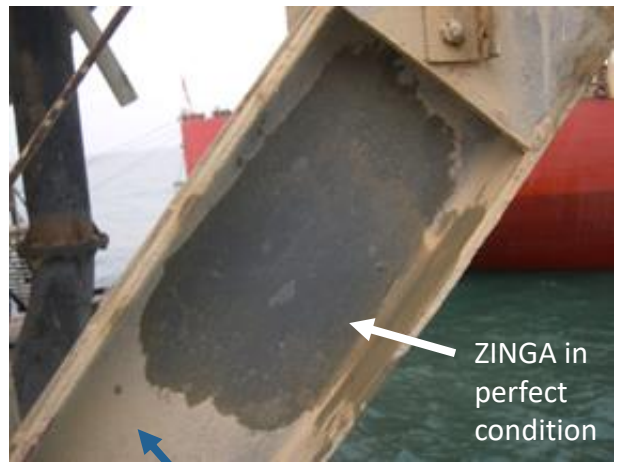
Evaluation inspection 2006 after 10 years!

- At first sight: bad condition because of a lot of dirt.
- At close look: phosphate dust & other deposits!
- Adhesion test: excellent result
- Overall good condition of **ZINGA**
- Some local formation of blisters

Phosphate dust

Only some local minor repairs had to be done to remove blisters (due to solvent retention) and rust spots (due to mechanical abrasion and local bad surface preparation).
The main contractor was Sogea Satom (VINCI Group).

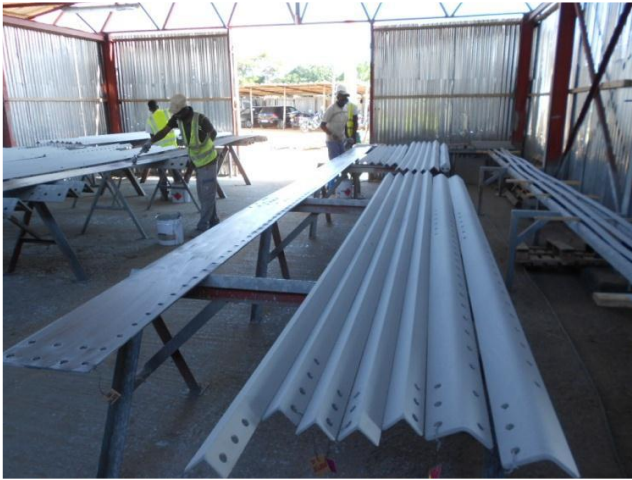
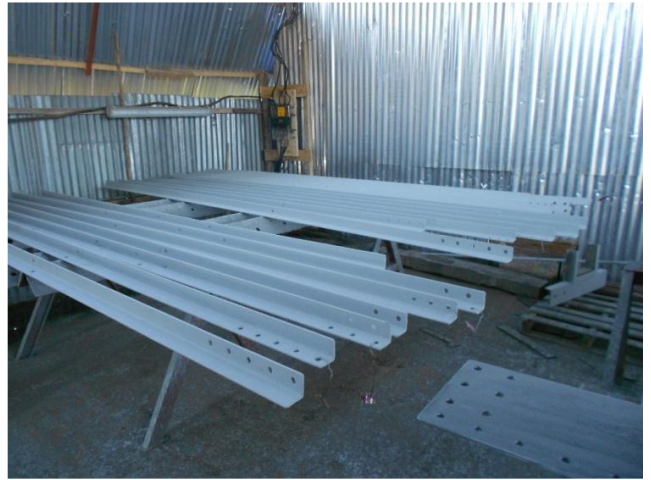
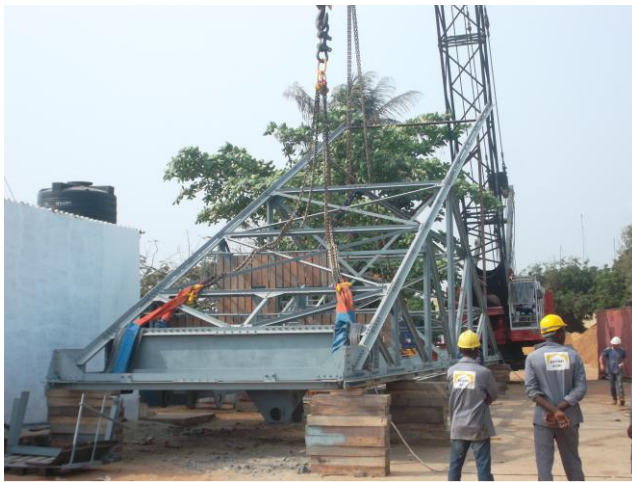
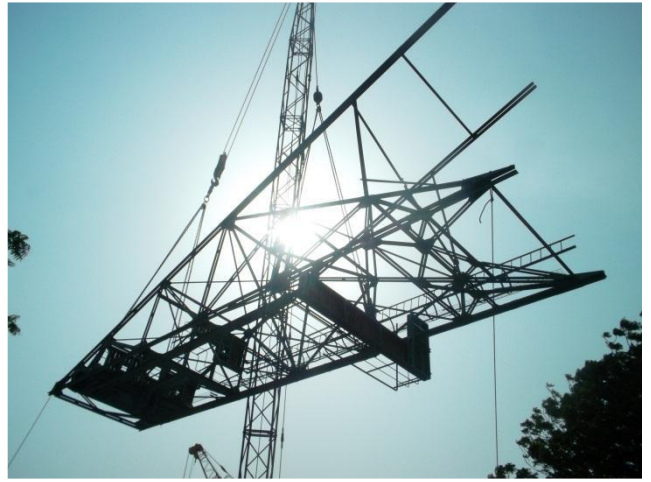
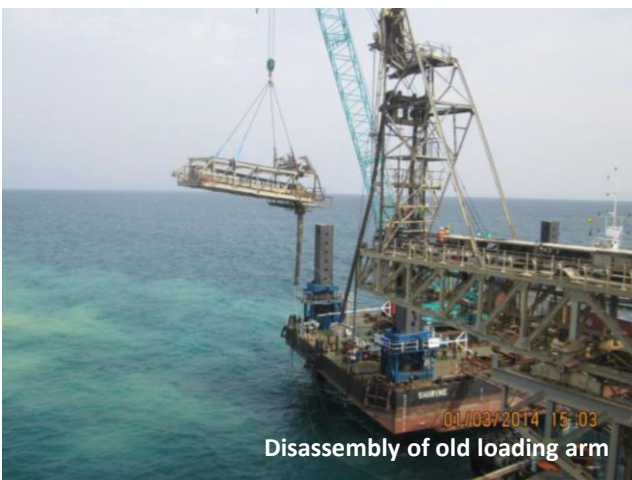
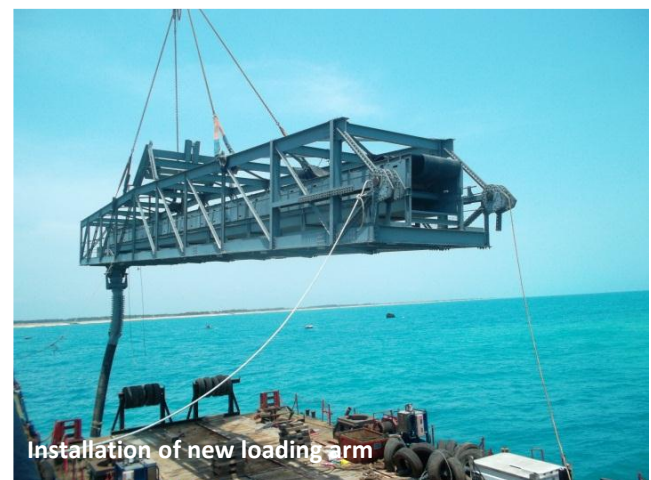
In 2014, the loading arm and pylons of the cranes were damaged and needed to be replaced. For this replacement structure, **ZINGA** was also specified. In the same refurbishment project, and a rail transport bridge was also protected with **ZINGA**.
