NEWARK MARINA BRIDGE - UNITED KINGDOM

These are pictures of the **Newark Marina Bridge** in the United Kingdom.
The bridge was blast-cleaned, Zinganised and painted in 1998.

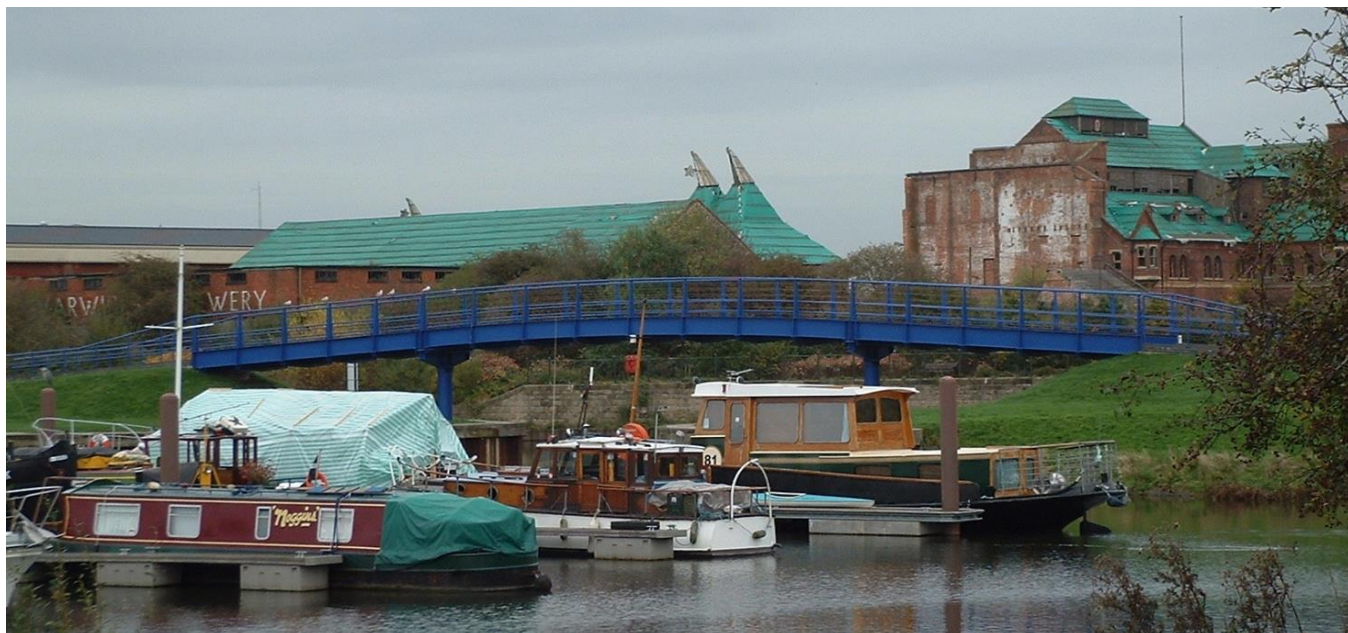
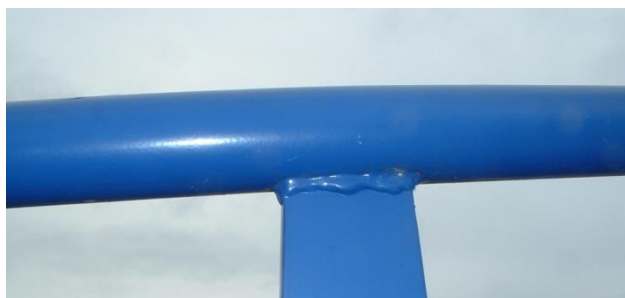
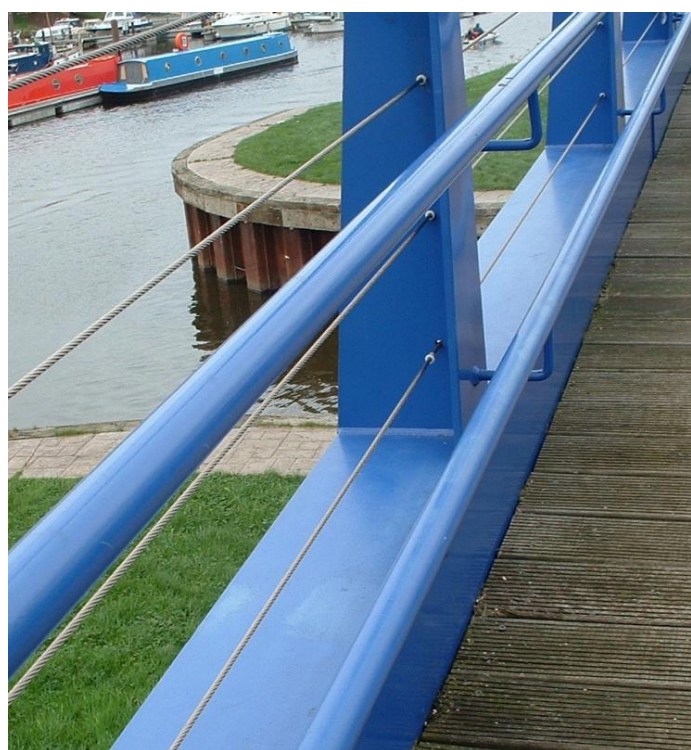
7 years later, in 2005, an inspection was carried out.
The system that was used (**ZINGA** + single-pack polyurethane paint), was still in very good condition.

System:
Blasting to SA 2.5
ZINGA 1 x 60 µm DFT
single-pack polyurethane paint
