ROYAL TRAIN SHED – WOLVERTON PARK – UNITED KINGDOM

Royal Train Shed in Wolverton: phase 1 completed

Triangular Shed in Wolverton: phase 2 completed

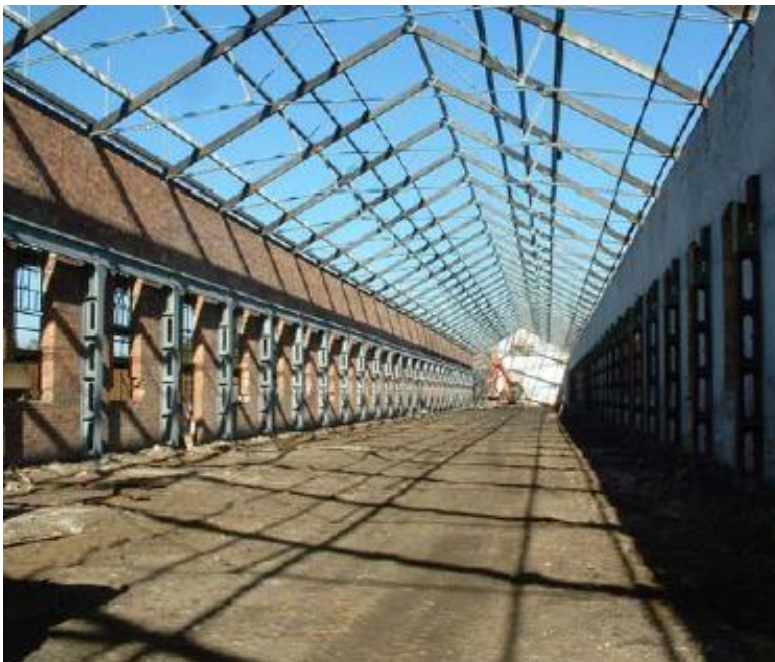
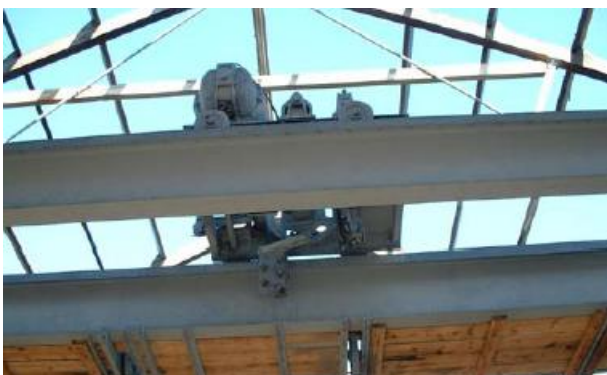
Some views of the 1893 **Royal Train Shed** in Wolverton Park, north of London, after application of **ZINGA** on the cast-iron upright beams and the roof-ties.

The steel cross-beams above the iron uprights to support the original overhead crane, as well as the large cast-iron window frames, were also blast-cleaned and protected with **ZINGA**.

ZINGA 2 x 60 µm DFT

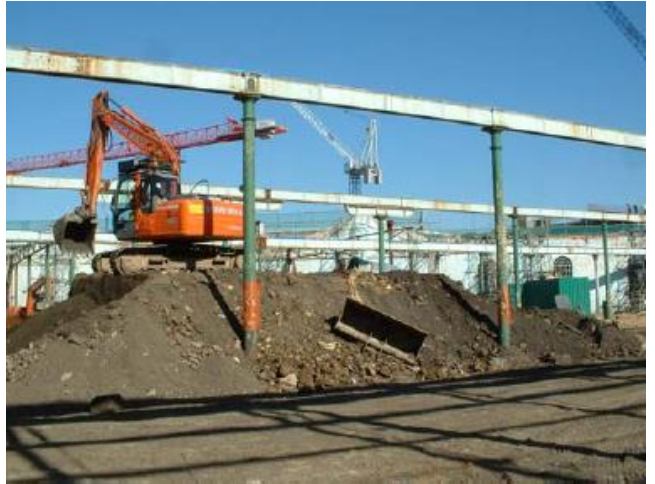
Views of the beginning of phase 2. The old floors are being broken up and removed along with the cracked and broken cast-iron guttering, down-pipes and other old debris that cannot be repaired or restored. Works started on 15th October 2007.

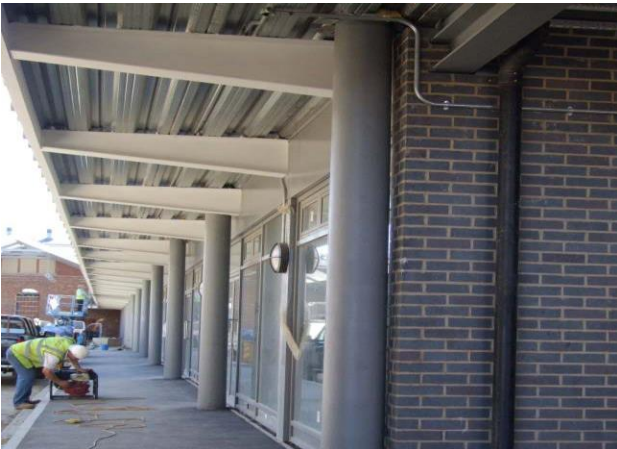
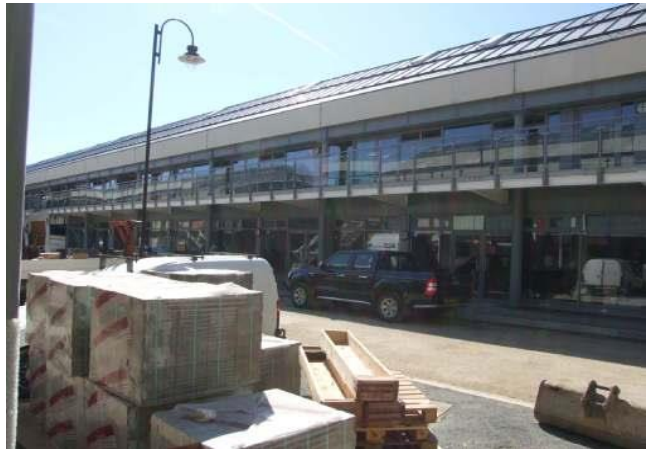
After eight months, the consulting engineers said that the architects did not want a matt-grey finish, and so a semi-gloss acrylic coating of 50 μm was applied over the ZINGA.

The cast-iron columns were left as original with **ZINGA** unique system.

Surface preparation:
Blast cleaning to SA 2,5 and
RZ 50-70 μm
ZINGA 1 x 80-100 μm DFT
Acrylic semi-gloss paint
1 x 50 μm DFT
