LIGHT POLES – TERMINAL KATOEN NATIE CUENCA DEL PLATA MONTEVIDEO – URUGUAY

On 3 June 2009 a test application was done at the KATOEN NATIE Terminal of Cuenca del Plata in Montevideo.

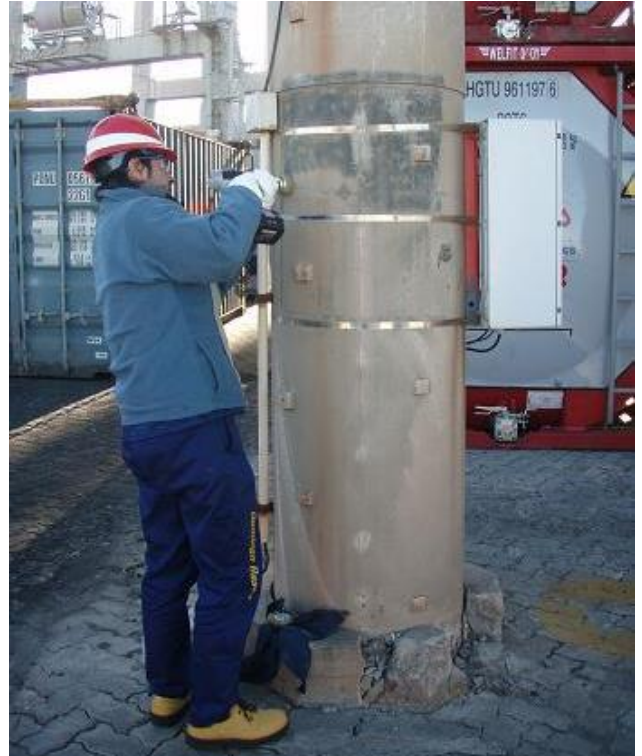
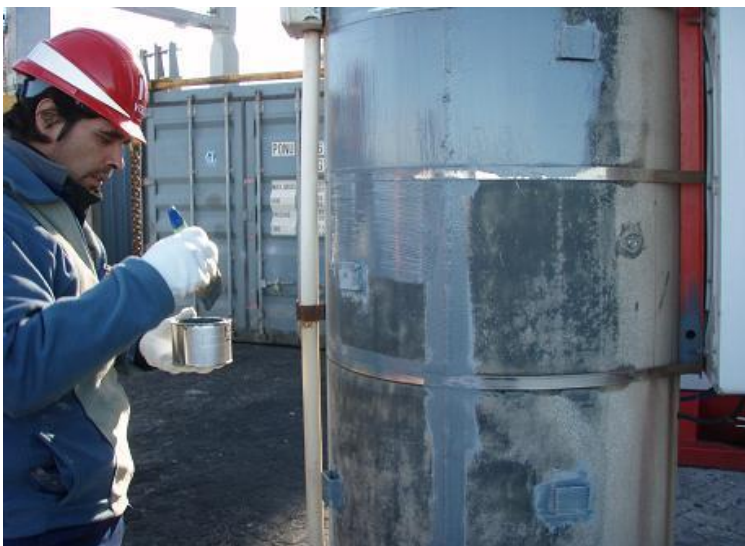
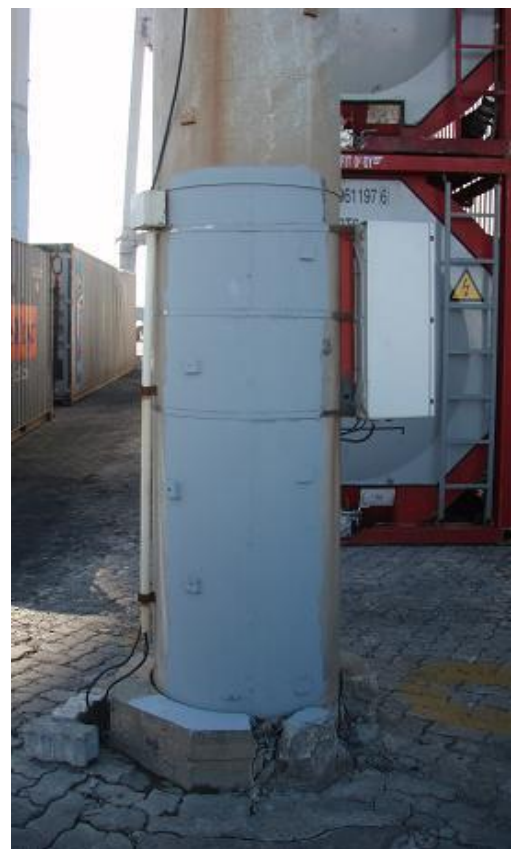
Surface preparation:
Copper brushes

ZINGA 2 x 60 µm DFT

On the 30 October 2009 (after 5 months), the site was revisited, and no sign of any failure was noted (not even the parts that are more sensitive to corrosion).

- Mechanical wire brushing with copper brushes to remove zinc salts and corrosion, without polishing the surface.
- Washing the surface with water + 5% ammonia.
- Drying the surface with clothes
