REF: BR-EL-HU-PY-TE-ZU-  
Furnas Electricity Pylons – EN  
04-11-2024 – ZP0076

### FURNAS Electricity Pylon – Serra do Mar, Brazil

Aplicação de ZINGA na torre 205 da  
LT 345 kV Ibiuna - Tijuco Preto circ. 1 e 2

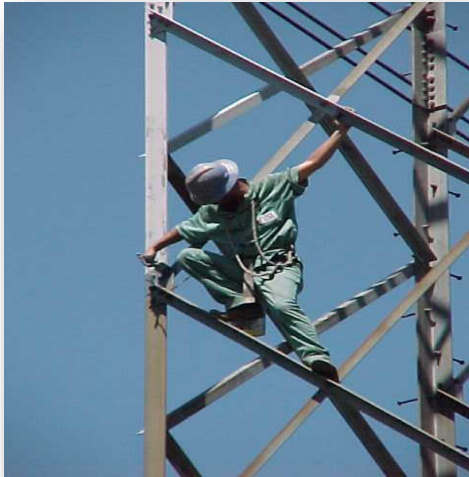
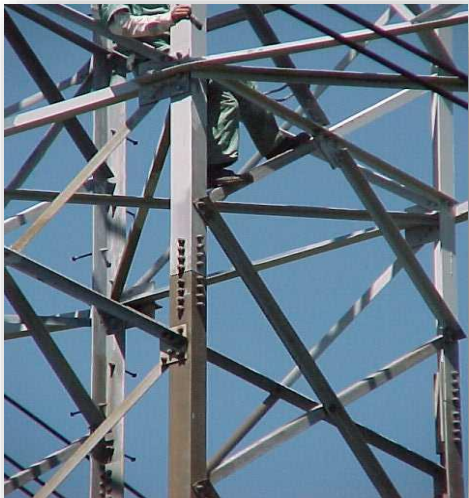
ZINGA was applied on a highly corroded high tension power pylon of the electricity company **FURNAS**, in February 1999. The surface was manually prepared by metal brush, sand-paper and by degreasing with turpentine.

**Zingasolv** was used to clean the brushes and to dilute the **ZINGA** when necessary. Considering the aggressive area, 2 layers were applied with a DFT of 40 µm with an interval of 2 hours. The total surface was 332.31 m<sup>2</sup>. 5 Kg **ZINGA** pails were used covering 11 m<sup>2</sup>.

**ZINGA** was applied in an ambient condition of high humidity.

Adhesion tests gave a very positive result.

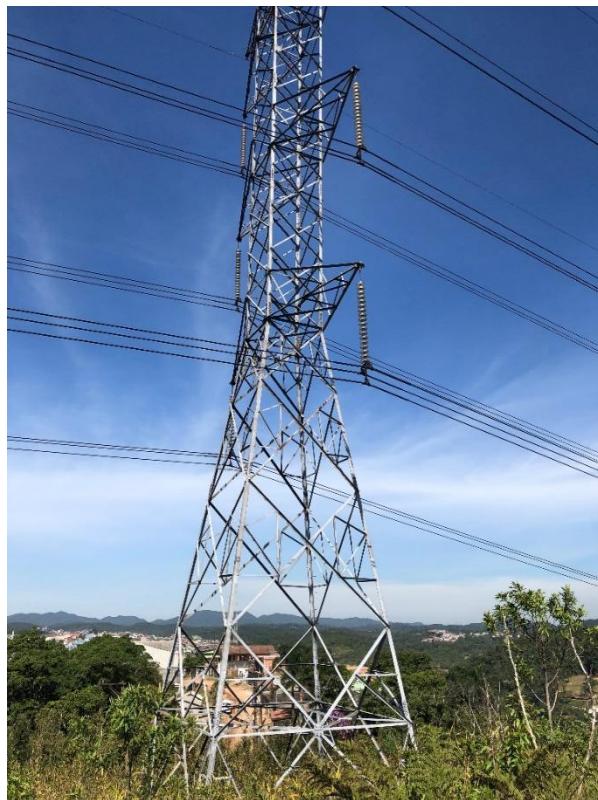
20 years later, on 9 August 2019 **ZINGA BRAZIL** made a visual inspection on an unusual sunny day. The location is close to a village (Ribeirão Grande da Serra – SP, east of the City of São Paulo) on top of the Serra do Mar (Sea Mountains), a very rainy and foggy place. It is close to the chemical plant of **ELCHLOR** (Chlorine manufacturer). **ZINGA** is still in pristine condition and does not need to be reloaded.

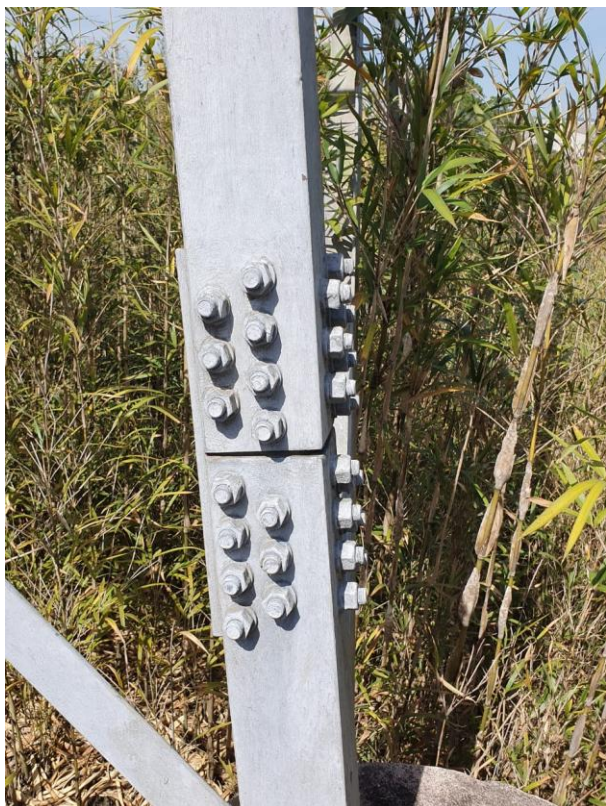
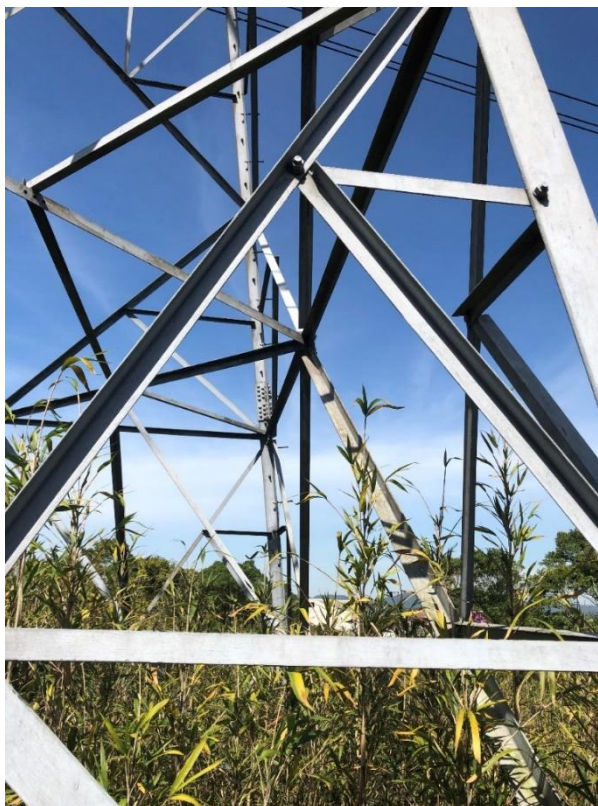
25 years later, in March 2024, ZINGA BRAZIL made a new visual inspection. It was confirmed that the quality of the ZINGA film remains in excellent conditions, even after this long period in several conditions of humidity and temperature, ZINGA still and effectively protects the substrate against corrosion.
