# British Railway Stock Rails Blasted & Zingانىsed.

Zinga treated stock rails in a storage yard in Scunthorpe UK

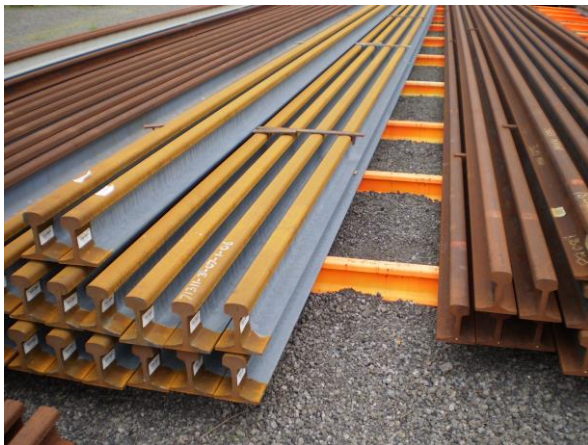
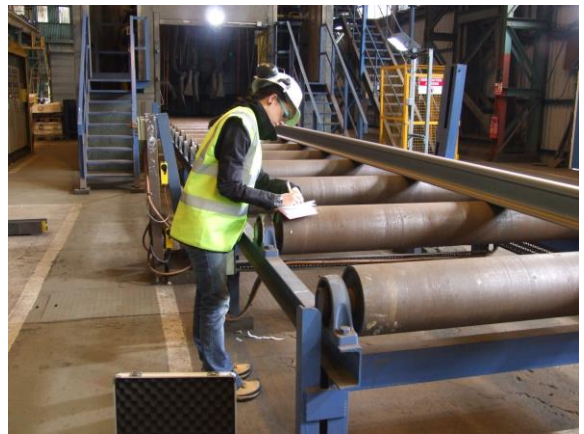
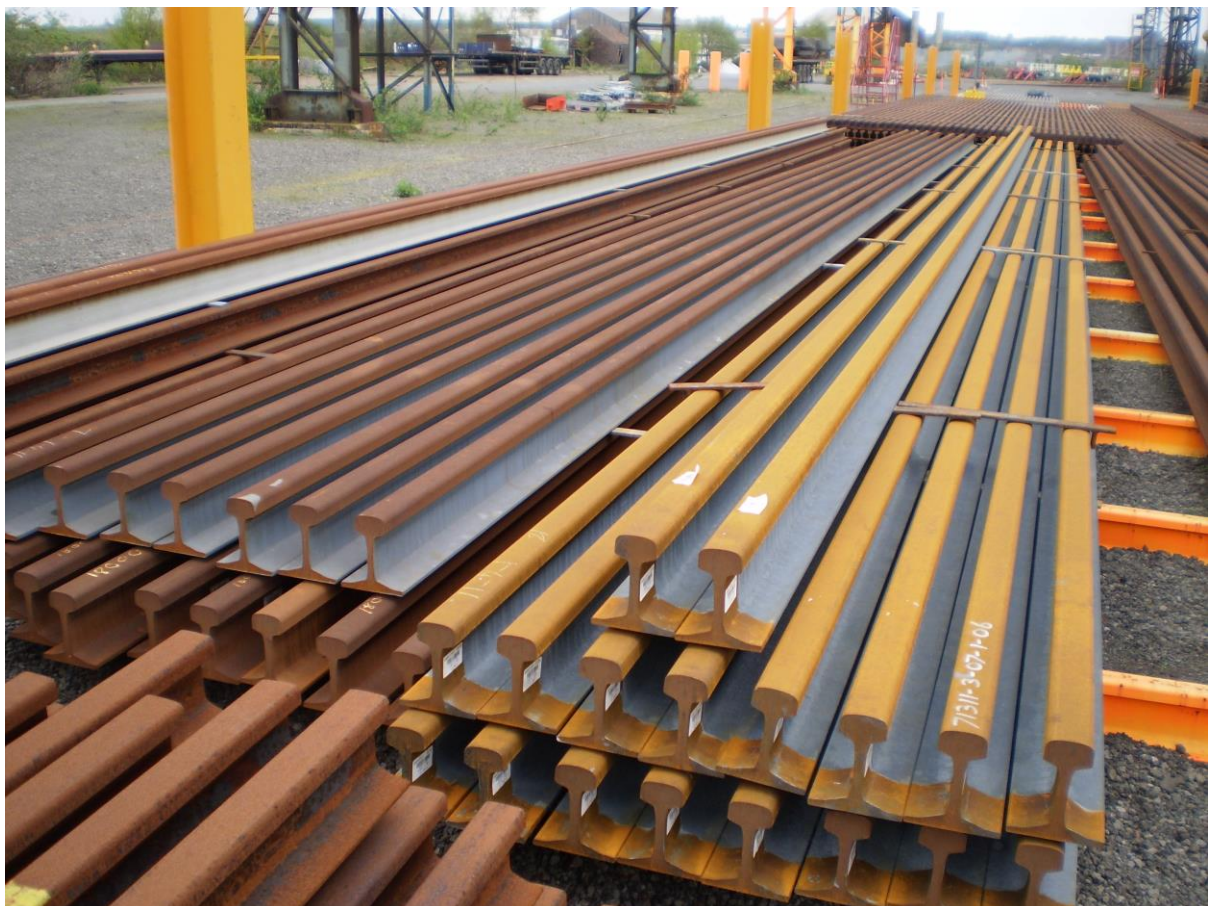
There are two photographs of the rail stockpiles, and you can see the orangey coloured rust on the newer rails and the dark brown rust on the older rails.

The older rails have been in storage for 4 – 5 weeks and are now ready for shipping to their new rails site for installation.

By the time they are shipped their adhesion has gone from the initial 6.4 MPa up to around 9.0 MPa, so they can be thrown around without any damage to the Zinga coating.

The rail crowns are never blasted and coated because the blast would reduce the hardness of the crown on which the wheels run.
