DÜSSELDORF AIRPORT – GERMANY

ZINGA was applied on steel structures of the Airport of Düsseldorf in 1990, namely on a hangar, with a height of more than 30 m, that serves as testing area for the engines of large commercial airplanes and of which the interior side has been insulated with panels. There is a steel structure between the insulation panels and the concrete building. The entire steel structure has been protected with **ZINGA** as unique system. The applied **ZINGA** layer thickness was 120 µm. The company **DILLINGER STAHLBAU** executed the job.

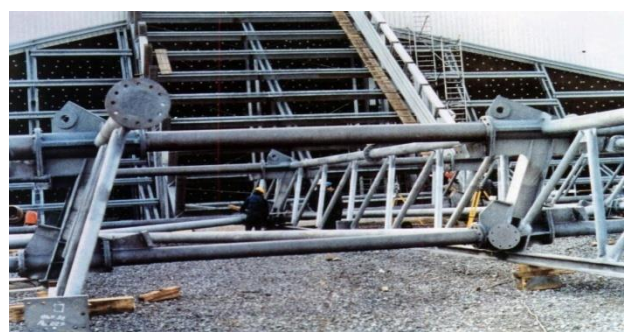
The following additional information concerning the application of **ZINGA** in the airport of Düsseldorf was transmitted to us by Mr. Schwarz on **17-10-2000**: the protection of the welding seams was carried out very soon after the welding seams had cooled down to temperatures below 40 to 35 °C and after they had been properly cleaned. Since welding seams usually do not have a rough surface, the **ZINGA** was applied in a thin layer. Afterwards, the **ZINGA** was built up to the required thickness of approx. 150 µm which complied with the layer thickness of the steel construction as specified by the customer. No further passive coatings such as paints were applied at that time. The application was carried out inside the workshops. The welding seams were checked by ultra-sound equipment by an officially recognised institution before the final assembly on site.

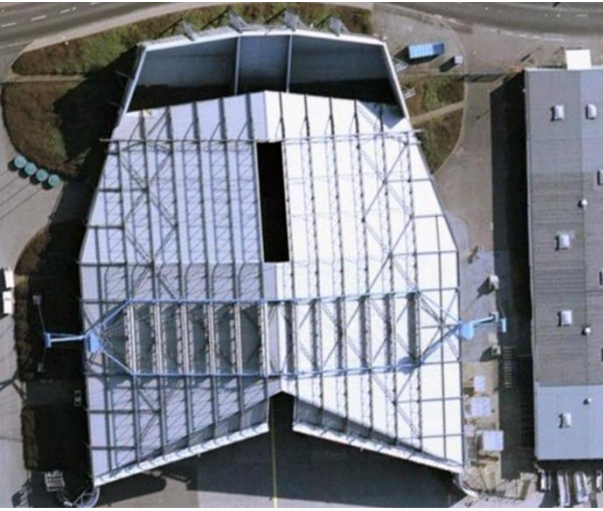
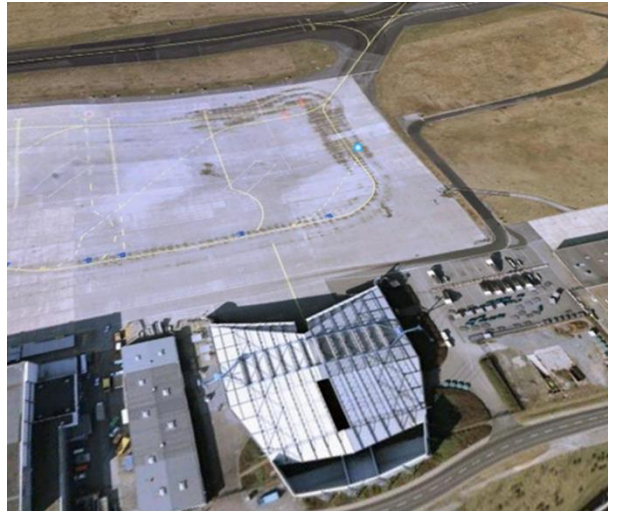
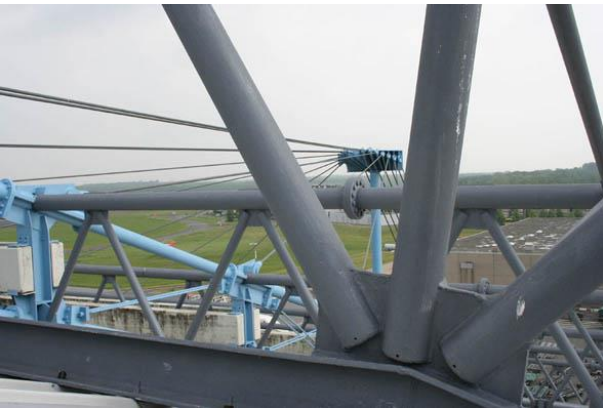
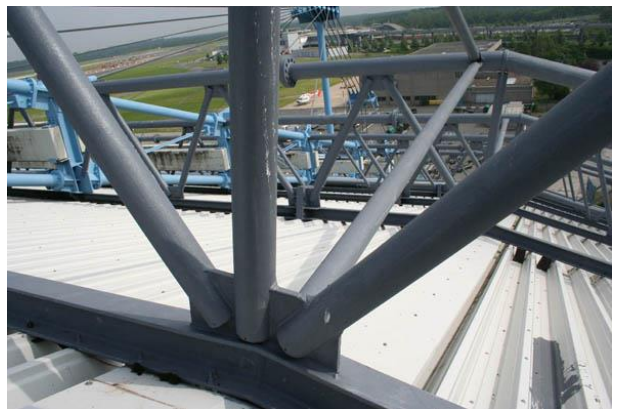
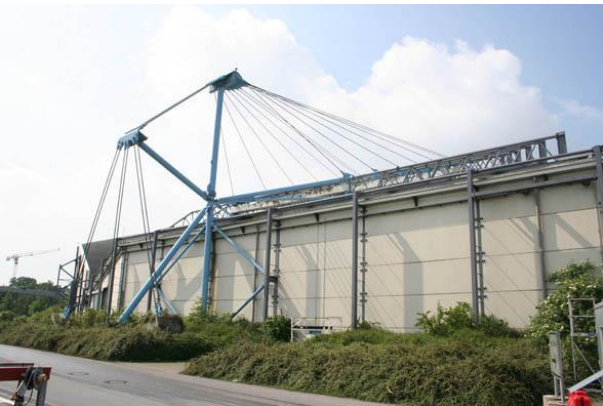
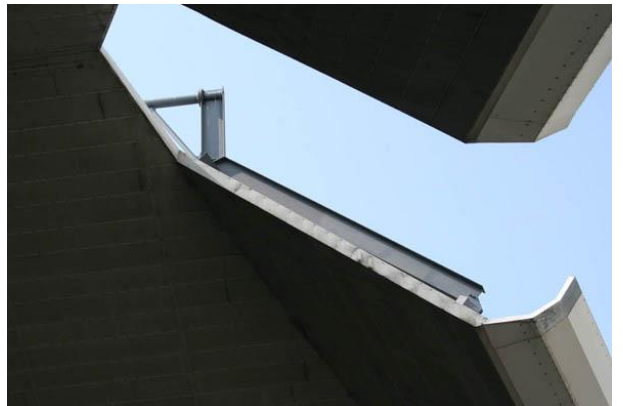
Some time before checking the structure's condition in presence of the airport authority in **May 2008**: the steel structures on the outside of the building and on the roof have been over coated after the 10-years guarantee-period, despite the fact that there were no complaints or traces of corrosion. This was done for aesthetic reasons and given the aggressive environmental circumstances on the outside of the building. The topcoat consisted partly of a blue colour paint and partly of a MIO based paint.
