KALVØYA BRIDGE – BÆRUM – NORWAY

In 1985 **ZINGA** was applied by brush on the steel structures of the **Kalvøya Bridge** located in the **inner Oslo fjord**. Paint gloves were used for the carrying cables.

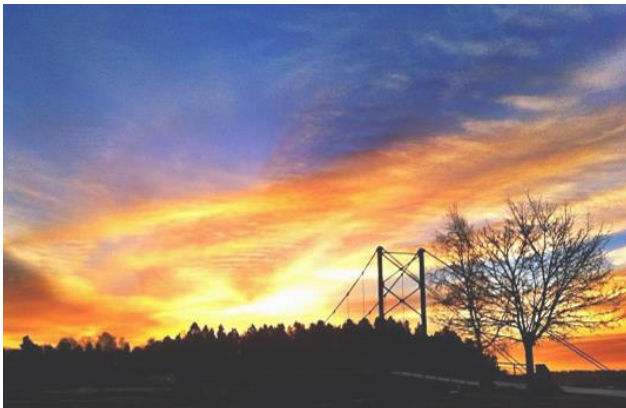
The Kalvøyabrua was inspected in April 1995 by det Norske Veritas Certification A/S.

Their comment in 1995 was that this bridge was in a good condition. Compared with the control in 1985 (another system for about the same period of time) the bridge was in a considerable better condition regarding corrosion protection of the steel parts and carrying cables.

It took 5 kg ZINGA to touch up the entire bridge for some small scratches, and this 10 year after the first treatment.
