## Spillway Gate: Located on the island of Jura, Scotland.

Completed during 2015

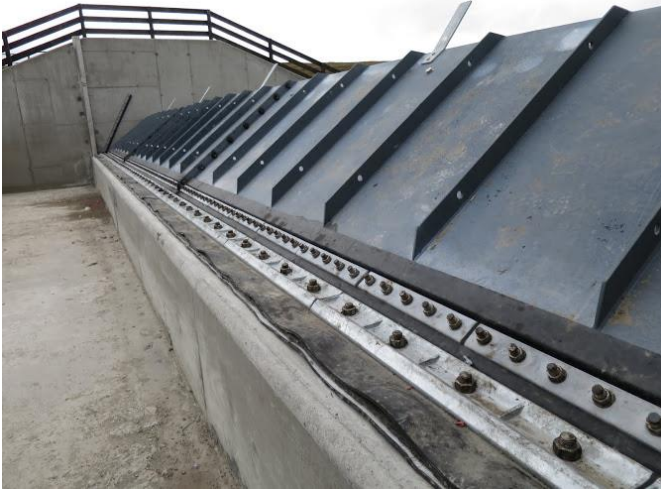
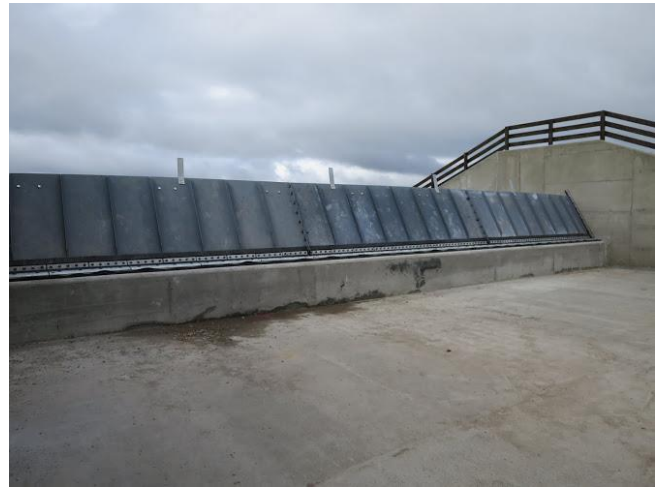
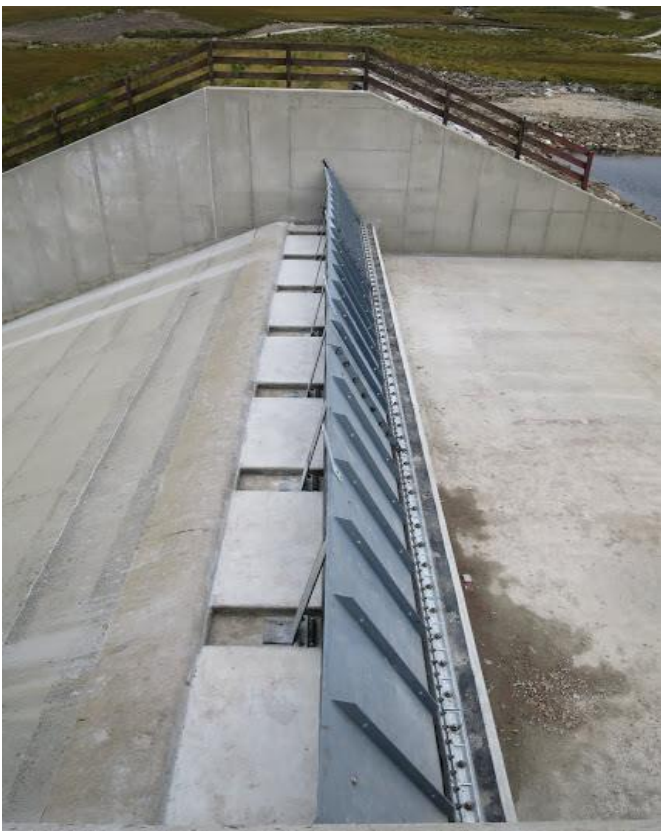
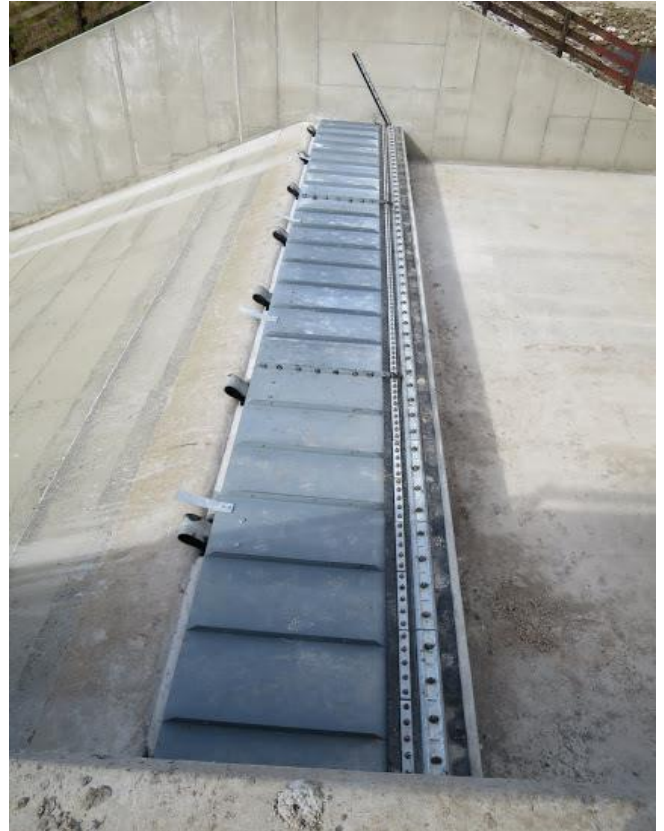
The bluish colour of the Zinga layer on the flood-gate indicates that the protective zinc carbonate salts have fully formed across the surface of the zinc, and also internally within the film. Although this small island is surrounded by sea, there are only a few small areas of zinc salts on the surfaces of the gates, as the zinc layer has been passivated and is now less reactive.

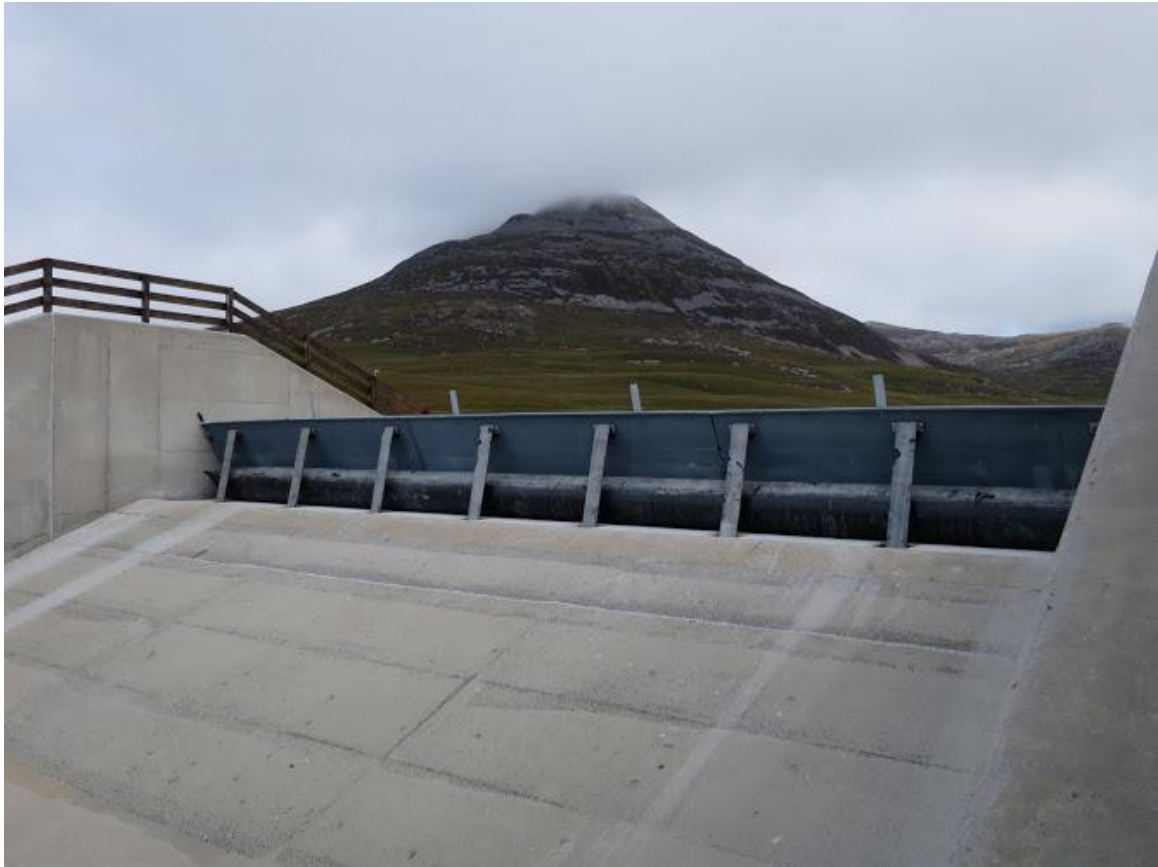
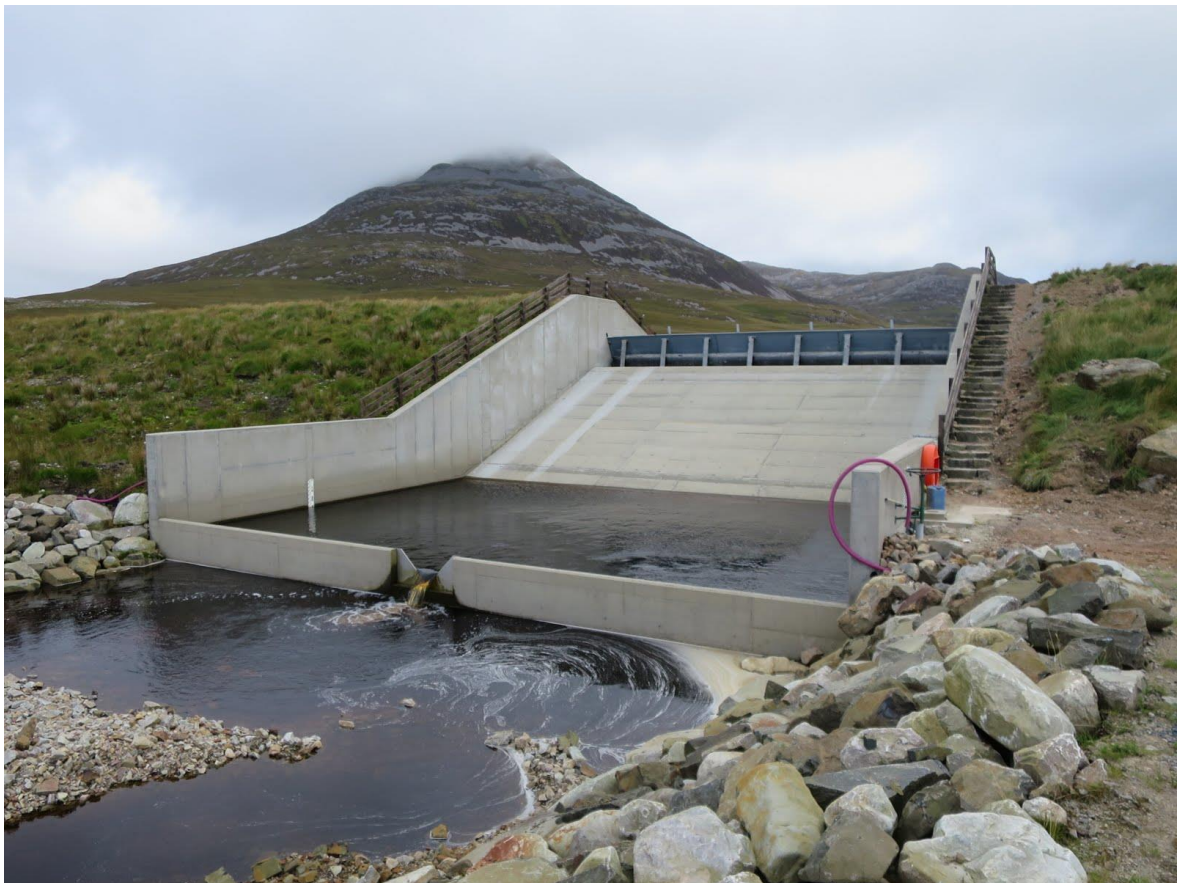
Two views showing the concrete spillway as viewed from the bottom end
