## MOLISSON STREET BRIDGE – AUSTRALIA

The **Molisson Street Bridge** is in Kyneton, Northern Victoria, Australia and has served the past 100 years for traffic over the Compaspe River.

It is the first steel bridge structure protected with **ZINGA** for **VicRoads Design**.

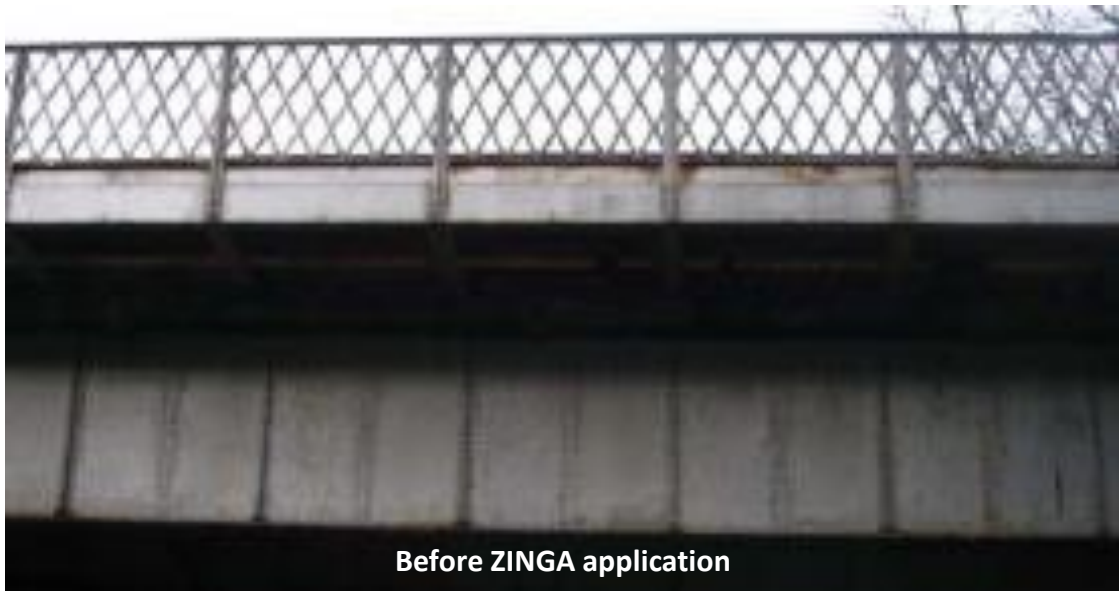
In the last decade it was showing rapid deterioration caused by corrosion.

The old coating had to be removed completely because of this rapid advancement of corrosion.

Site inspection in May 2007.  
(before **ZINGA** application)  
Note the increased beam corrosion.

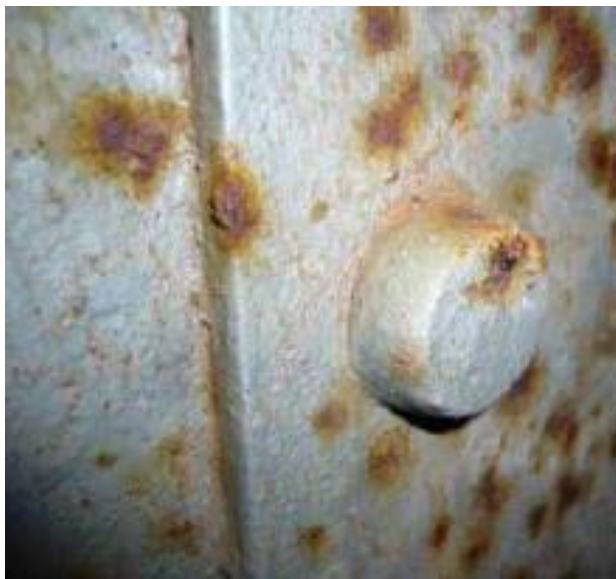
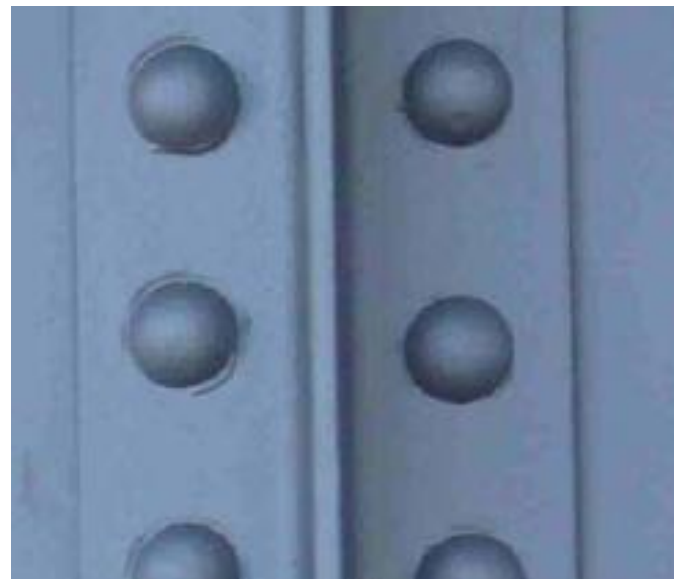
Typical view of **ZINGA** coated steelwork.  
All rivets, edges and bolts were stripe coated.

ZINGA	1 x 80 µm DFT
ZINGALUFER	1 x 80 µm DFT
Alufer WR Alu	1 x 80 µm DFT

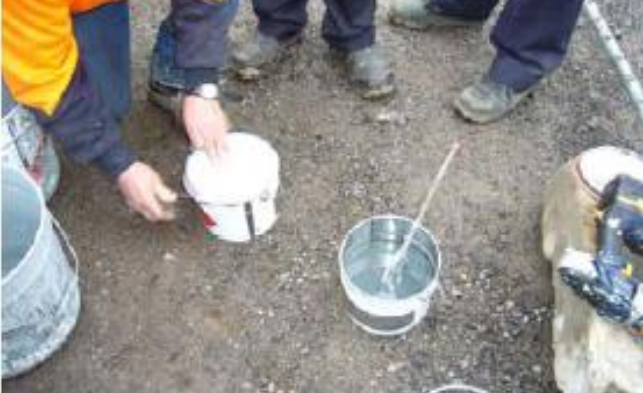
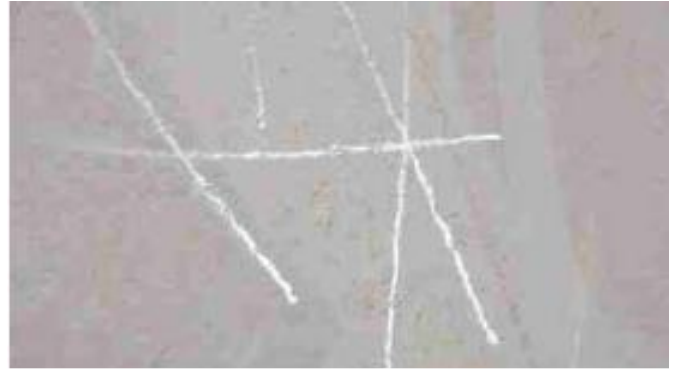
Photo Shows ZINGA "Film Galvanising".  
Scratched with a coin to show the  
pure active zinc exposed.

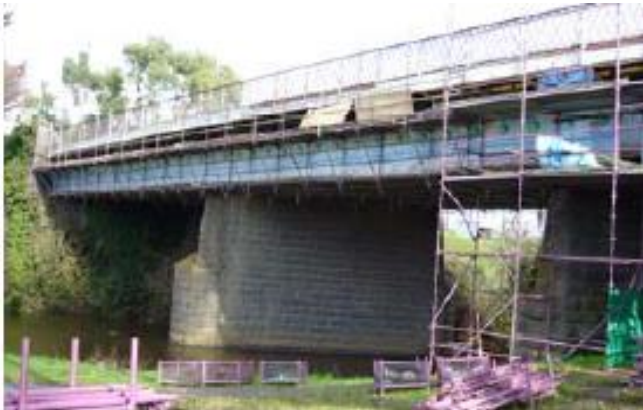
As previous coating system was lead based,  
the complete bridge had to be encapsulated.

### System:

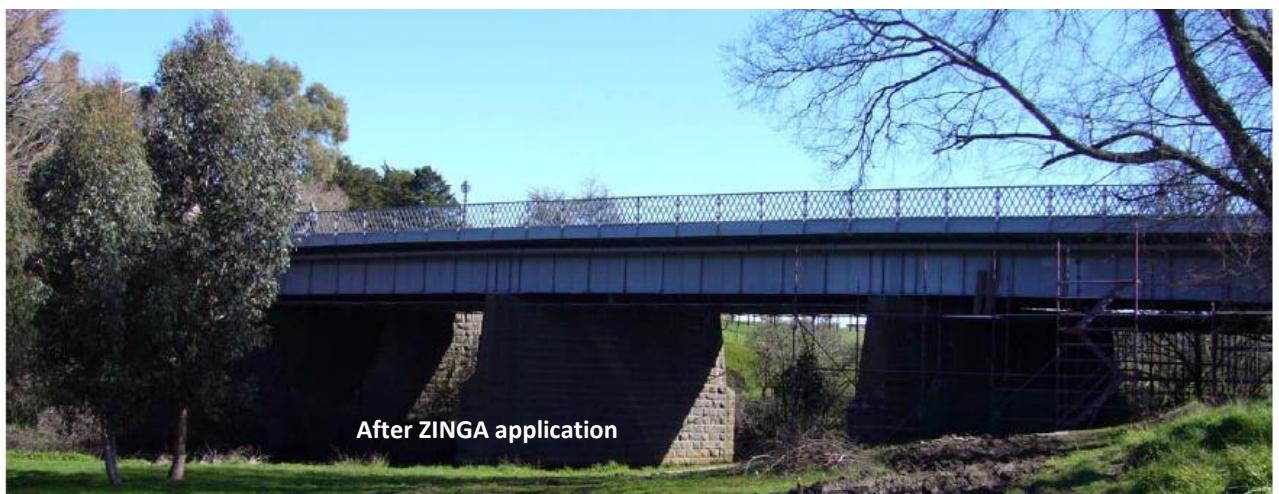
After ZINGA application

The ZINGA Coating system used on this bridge will provide exceptional long term protection for this "National Heritage" structure, including excellent UV resistance and weathering properties. The distinct advantage of using ZINGA as primer coat is that in many years to come the high volume of 96% pure zinc content of ZINGA will extend the service life by some 30 years.
