## STRUCTURES FOR BUILDING INDUSTRY – ROHR – BRAZIL

The main activity of the company **ROHR** is the renting of structures used in the building industry (scaffolding, tubes, ...). A test was done in June 1999, with iron structures that suffered from corrosion on places where small wheels frequently rubbed the metal surface. **ZINGA** was applied on 4 different scaffolds with a layer thickness of respectively 40, 60, 80 and 120  $\mu\text{m}$ .

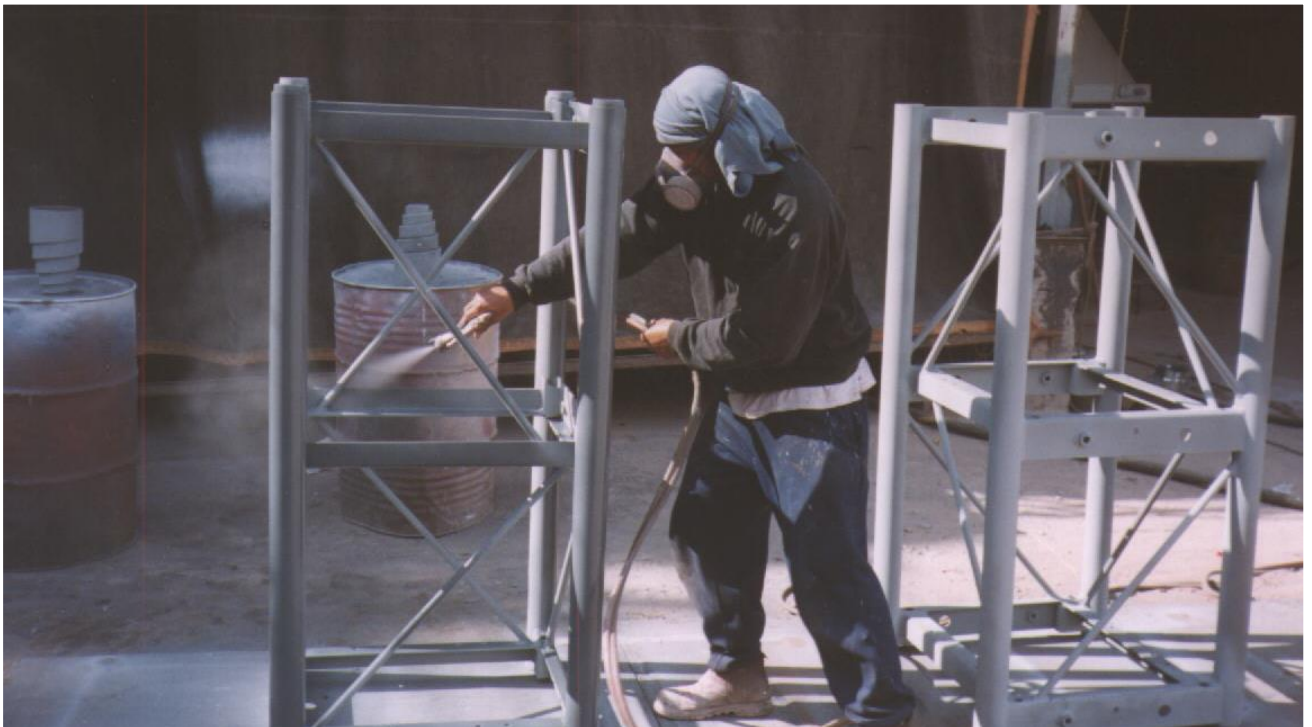
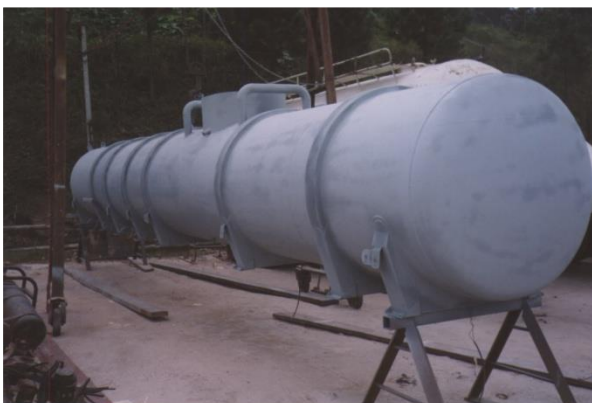
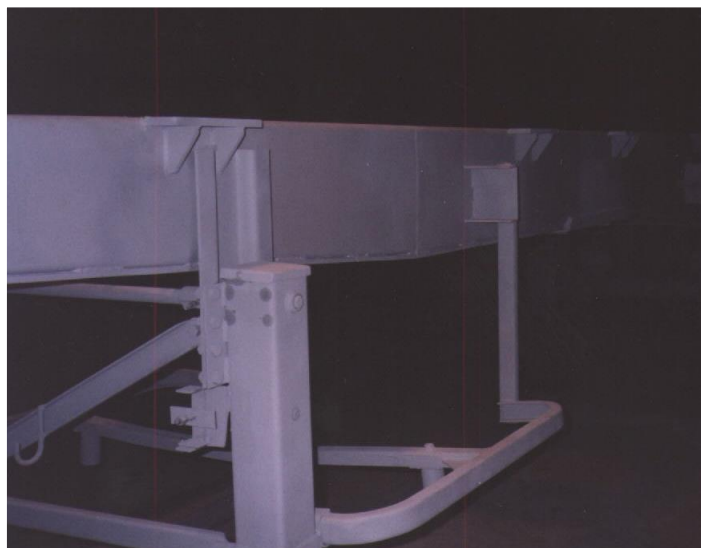
Pictures of the application of **ZINGA** on different iron structures by the company **ROHR**.

In November 2000, after more than a year of intensive use, not a trace of rust was visible on the scaffolds.
