## EL SALAAM BRIDGE – EGYPT

The treatment of the El Salaam Bridge in Egypt, was part of the Bridge Maintenance Program in 2007. This bridge carries a gas pipeline of the Egyptian Natural Gas Company (**GASCO**).

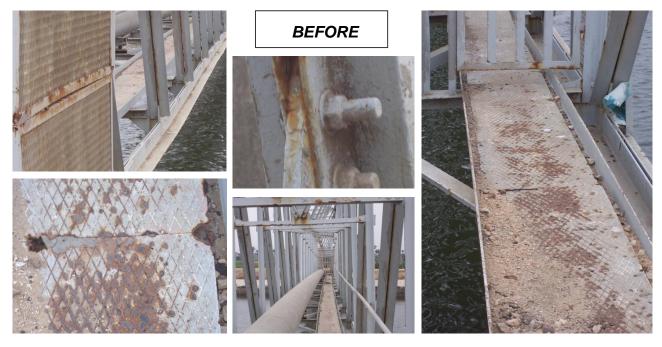
## The bridge had suffered severe corrosion. Some pictures before the **ZINGA** application:

Surface preparation:	
Sandblasting SA 2,5	Rz 75 μm
Most critical areas ZINGA (airless spray)	2 x 60 μm DFT
Other areas	2 x 00 µm Dr 1
ZINGA (airless spray)	1 x 60 μm DFT

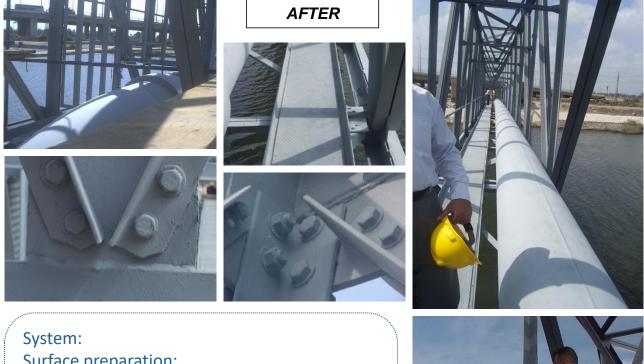
And pictures after the **ZINGA** application:
