TANGSTEDT BRIDGE – HAMBURG – GERMANY

Between March and April 2010 the bridge in Tangstedt (nearby Hamburg) over the Pinnau river was treated with **ZINGA** to protect it against corrosion.

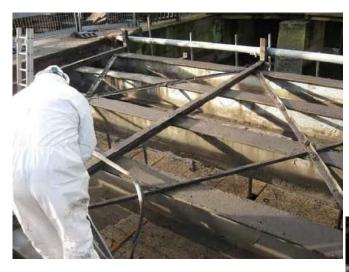
BEFORE

The surface preparation was done by means of slurryblasting or full blasting.

System: Surface preparation: SA 2,5 and Rz 50-70µm ZINGA 2 x 60 µm DFT
