PIPRAKHALI BRIDGE - INDIA

The Piprakhali bridge is under the **Irrigation and Waterways Directorate**, Govt. of West-Bengal. It is an important bridge in Basanti near Sunderban.

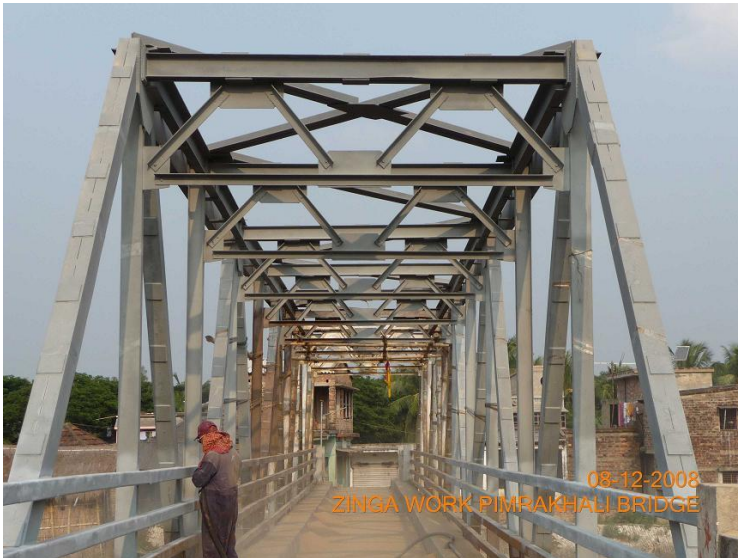
This fact was quite evident from the condition of the bridge which is just 8 years old. Some portions of the bridge were totally distorted due to corrosion and had to be replaced before the coating application could be started in 2008.

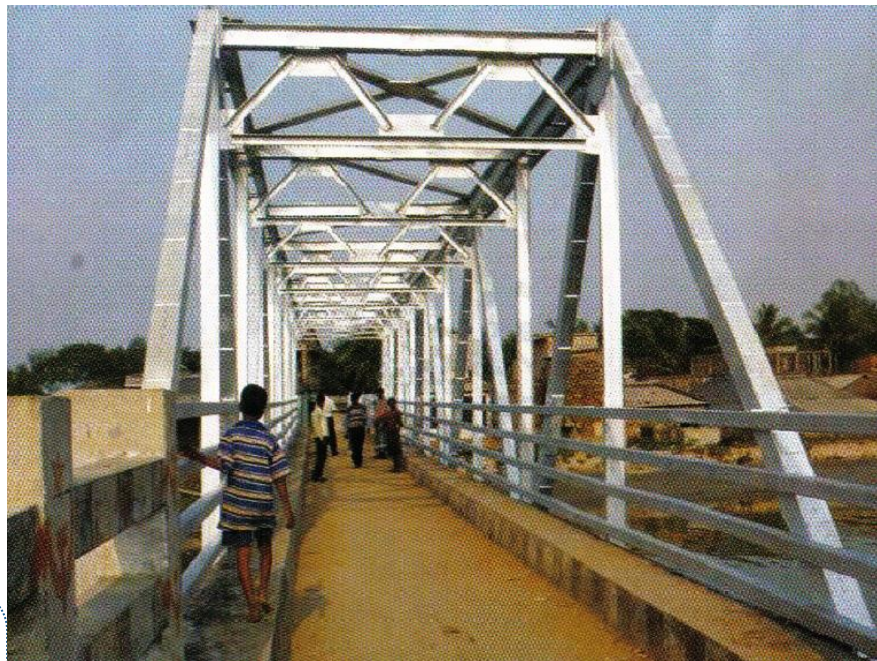
Aluminium
PU topcoat

ZINGA was topcoated with a MIO sealer and a PU topcoat with aluminium finish

ZINGA	1 x 40 µm DFT
MIO sealer	1 x 50 µm DFT
PU topcoat	1 x 60 µm DFT
