TRANSMISSION TOWERS – FORMOSA PLASTIC CY – TAIWAN

In 1999 ZINGA was applied by the company **UNITED FUEL TREATMENT** on top of the old and worn-out hot-dip galvanising layer on the transmission towers of the **FORMOSA PLASTICS COMPANY** in Taiwan (turn key job). See their testimonial hereafter.

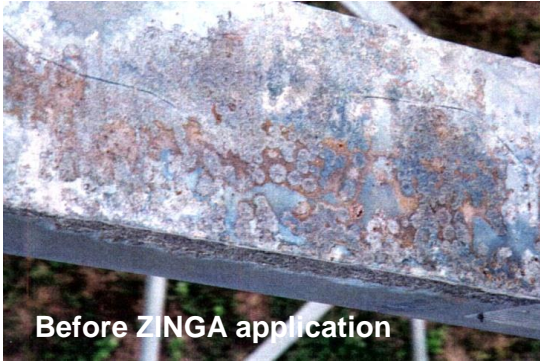
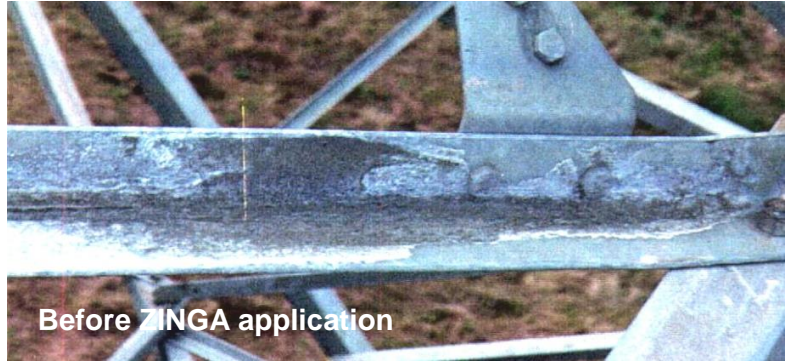
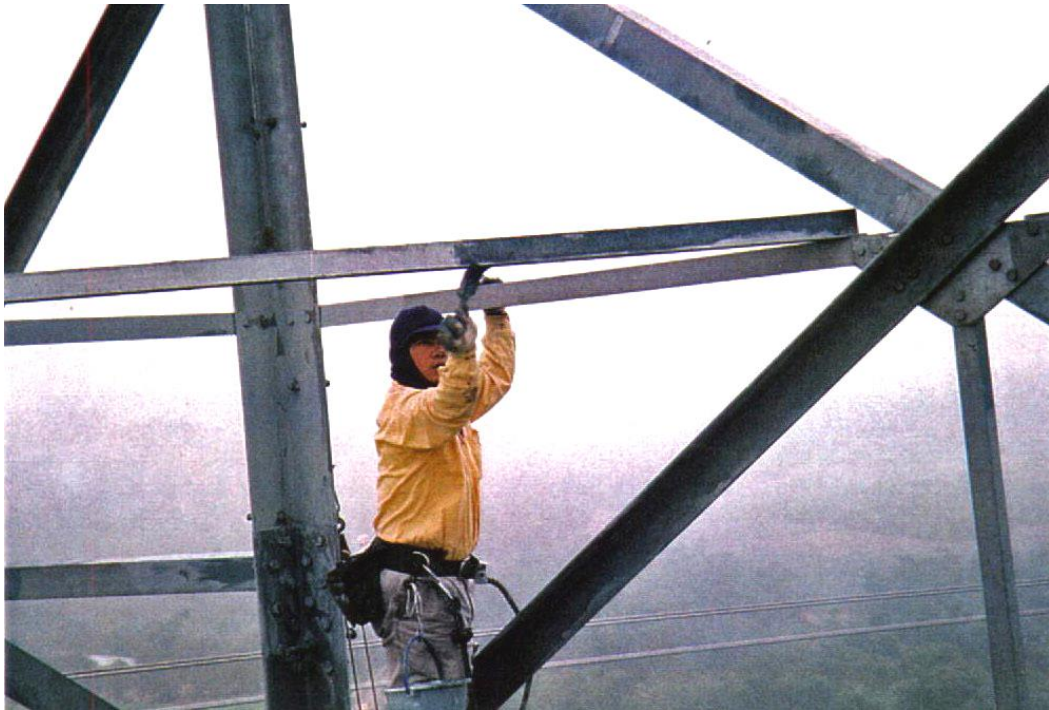
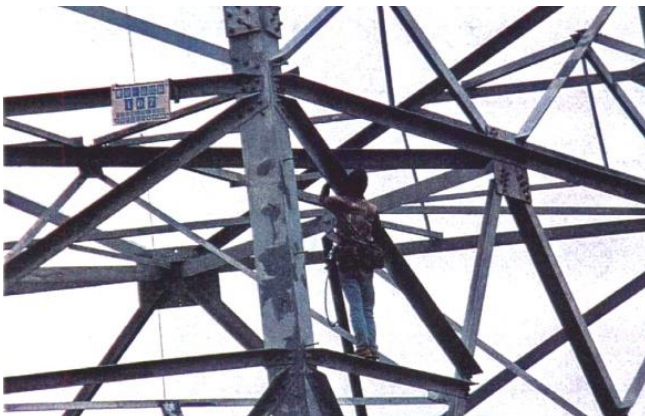
System:
New hot-dip but rusted
ZINGA 2 x 60 µm DFT

These pictures are showing the 345 KV transmission towers of the **FORMOSA PLASTICS COMPANY**, before and during the application on site. The towers are located in Mai-Liau in a very aggressive environment (tidal land).

It is said that HDG has a protection life of only +/- 12 months in this area.

We used ZINGA on the 150 feet-high transmission towers which is located on the tidal site really being a very aggressive environment. We were only able to apply 2 layers ZINGA by brush on jobsite one year ago. Its unique anticorrision property could be compared to hot-dip galvanization. The customers said that it can not be pealed off even hited by a hammer and till now no maintenance has been necessary. We have full confidence in the protection of the Zinga which is expected to have a span of 10 years life. They also said that they have never seen such a good paint-like system before. Therefore, they placed the second order with us this month.
