HIGH TENSION PYLONS – EGAT – THAILAND

EGAT, the **Thai national electricity company**, decided to use **ZINGA** to repair previously galvanised high tension pylons.

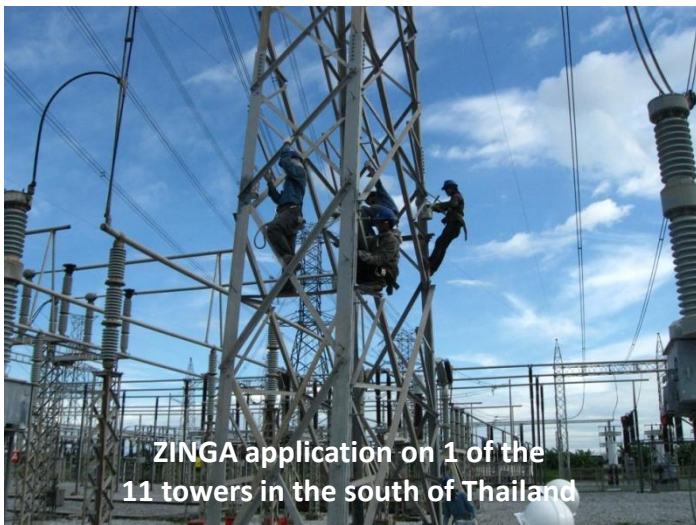
ZINGA application on 1 of the 11 towers in the south of Thailand

The feet of 11 pylons in the south of Thailand have been protected with **ZINGA** to give them complementary protection against the humid environment of the swampy area where they are placed.

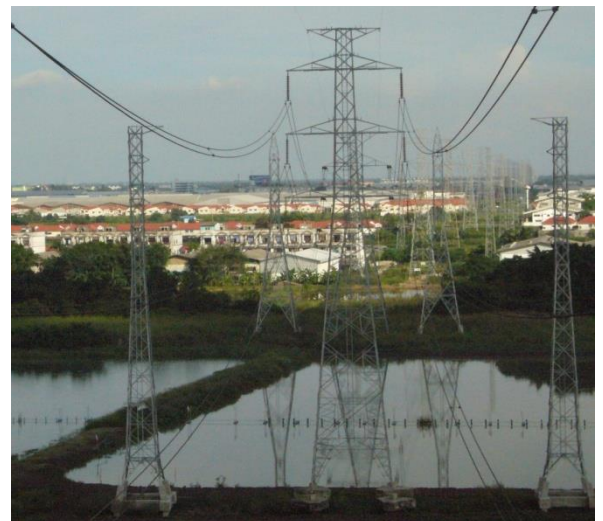
1 of the 15 towers near Bangkok in a very humid environment

ZINGA was also used on 15 high tension pylons in the region of Bangkok. The 8m high old previously galvanised towers and the respective base stations were repaired using **ZINGA**. Above ground 2 layers of each 50 µm DFT **ZINGA** were applied and below ground 1 layer of 40 µm DFT **ZINGA** was followed by 100 µm DFT **ZINGATARFREE**.

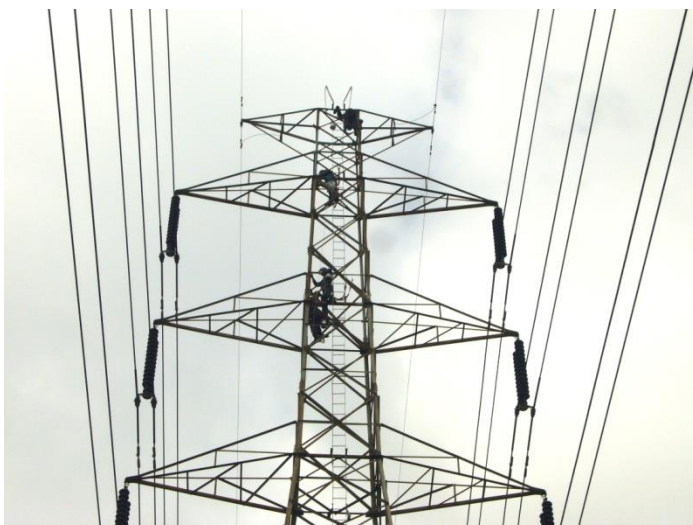
Application on a tower nearby Bangkok

System:

Above ground:

ZINGA 2 x 50 µm DFT

Beneath ground:

ZINGA 1 x 40 µm DFT

ZINGATARFREE 1 x 100 µm DFT
